**Chevrolet Four Cylinder
Engine Rebuild Discussion**

From the chat site of:
The Vintage Chevrolet Club
Of America

Teacher: Raymond Holland

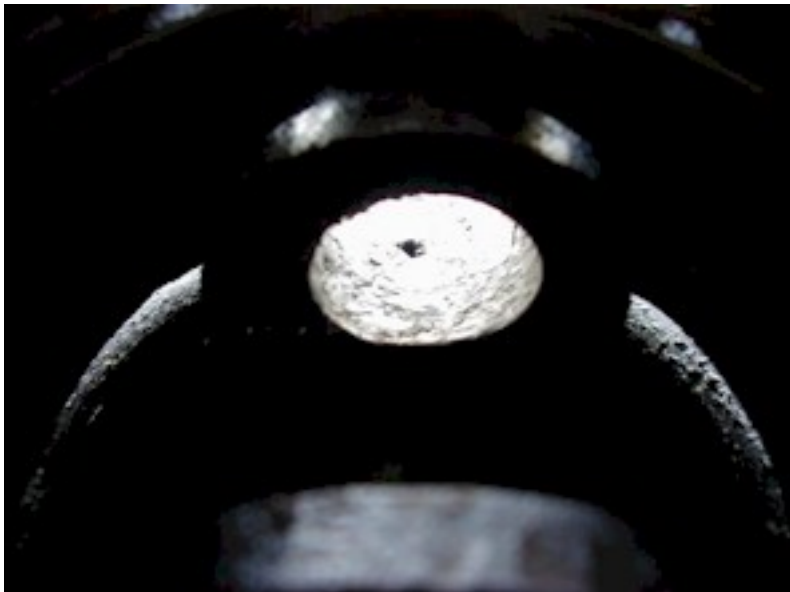
Took the piston and rod out to one of my trusted machine shops for their inspection and opinion. Upon close inspection in good light it was evident that the piston pin/piston was to blame for the problem. The pin was very tight in the piston and could not be slid from side to side. Brought the unit back to the shop and started to remove the piston pin. It moved some but refused to be extracted. Was able to get a look inside the damaged side and it was evident that the boss on the damaged side had completely disintegrated and particles of the piston were impregnated into the pin and would not let it be removed.

(Students I hate to admit this, but in attempting to remove the pin, in my frustration, I managed to break the oil ring). Now I am faced with an addition problem. Because only one side, the backside, of the piston failed, it caused the most damage to the rear of the piston. There were wear marks on the front side that indicated the piston was in a bind, but not near the damage as to the rear.

This next picture is a view of the piston pin boss nearest the firewall. Note that the casting appears to have 'sponged' in this boss. The other side of the piston reveals normal wear and no damage. Material in the damaged boss has transferred to the piston pin and attempted to 'freeze' the pin, however that never did happen. Go take a look and return.

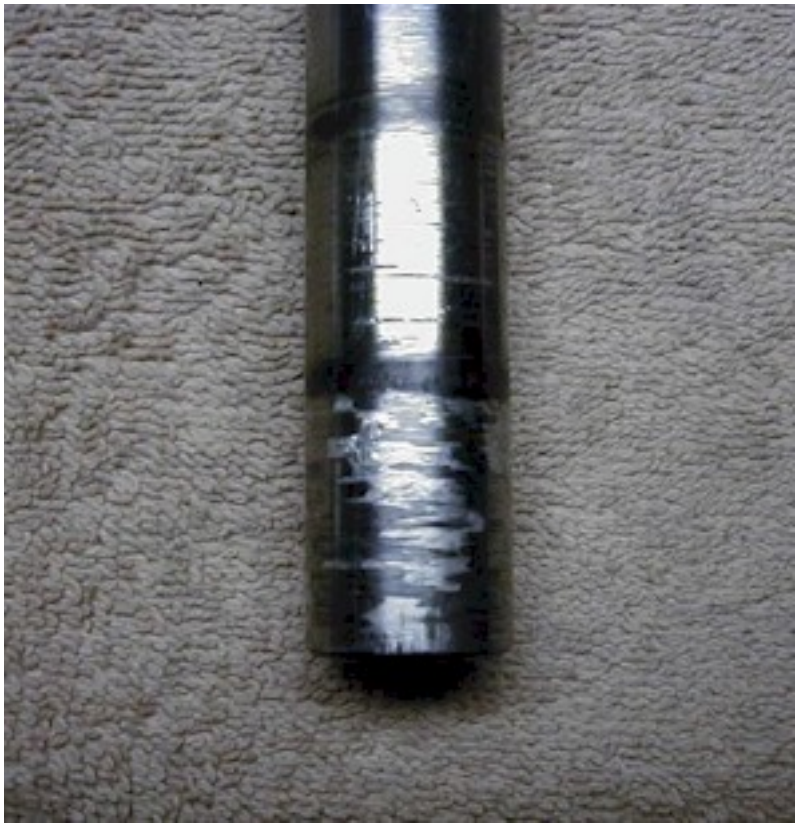
This next picture is of the end of the pin that received the damage. Note the buildup of material on the pin. Go look and return.

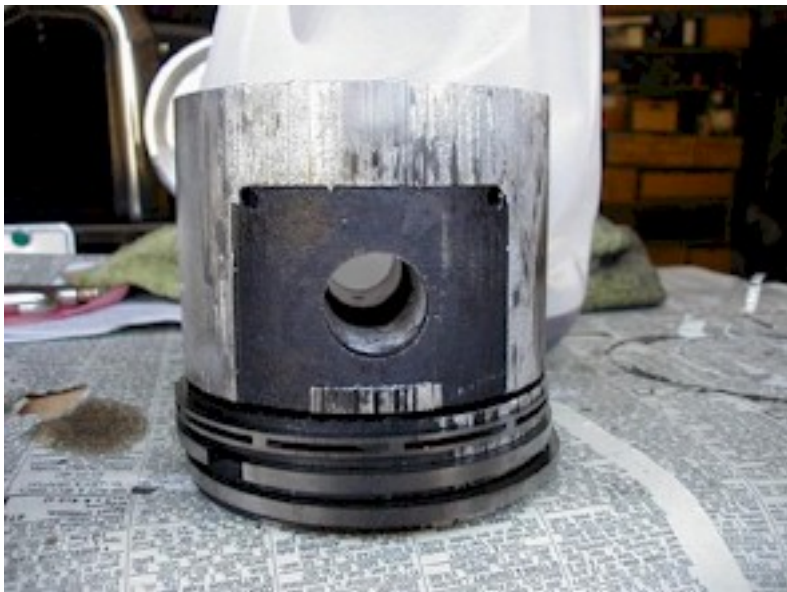
This last picture is the side of the piston facing the firewall and the side of the piston that had the damaged boss. Go look and return.

The rear (firewall side) of the cylinder was scratched. This area was honed out and would be considered servicable.

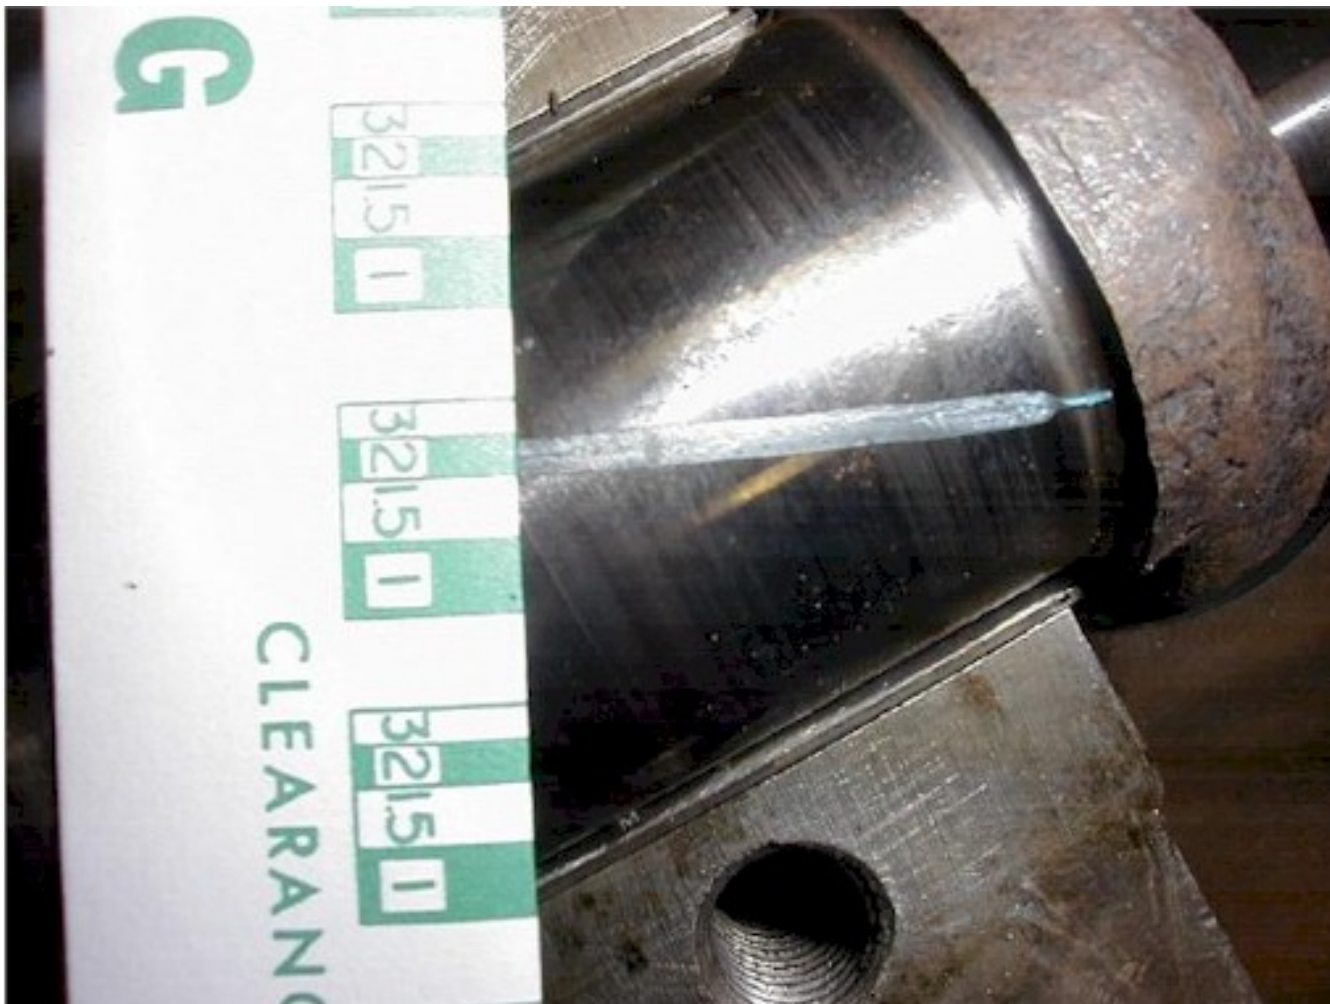
This is the rear main. I have laid the plastigage diagonally across the crank in order to measure some width along with the length. Actually, the crank should be measured at two different locations. With the crank at top dead center and at a 90 degree location. This is to check for egg shaped crank. Most wear on the crank would be at the top or bottom of the piston travel. All shims were removed from the rear main. It appears that my oil clearance is about .002. The repair manual does not specify a clearance for oil, however it does caution against having them too tight. This would cause heat that could easily melt the thin coat of babbitt. I am satisfied with the .002, but realize the next time the engine is repaired it will be necessary for new mains as there are no more shims to remove.

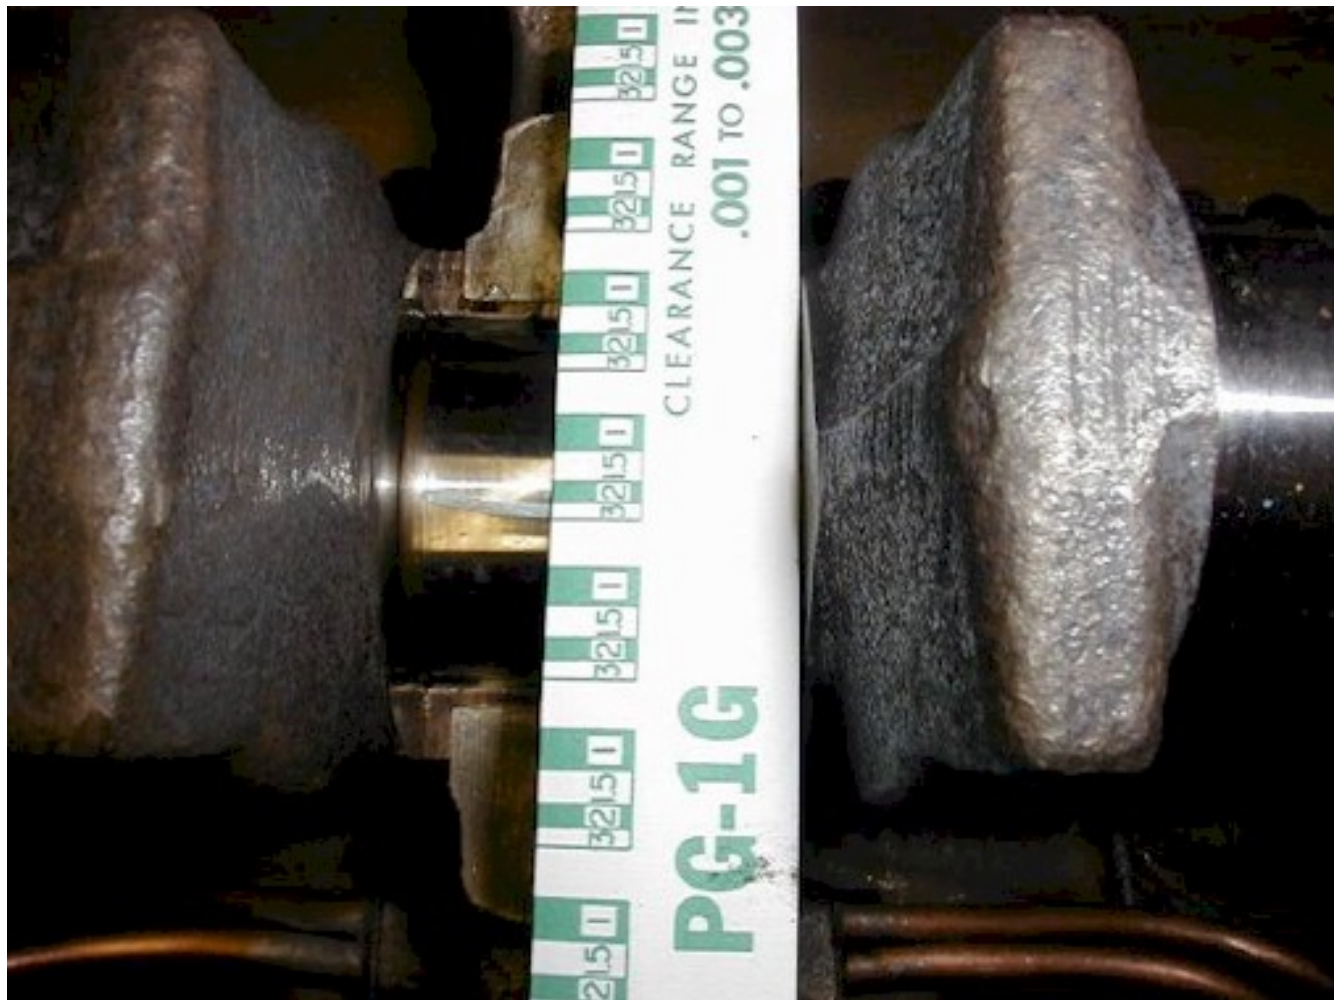
This is the center main. The reading here is also about .002+ and all shims have been removed here also. The center main serves as the thrust bearing in the 4-cylinder motor. When you push in on the clutch you are shoving the crank up against one side of the center main. The clearance for the center main thrust is .004 to .006. This clearance can be measured with a dial gage or by use of feeler gages.

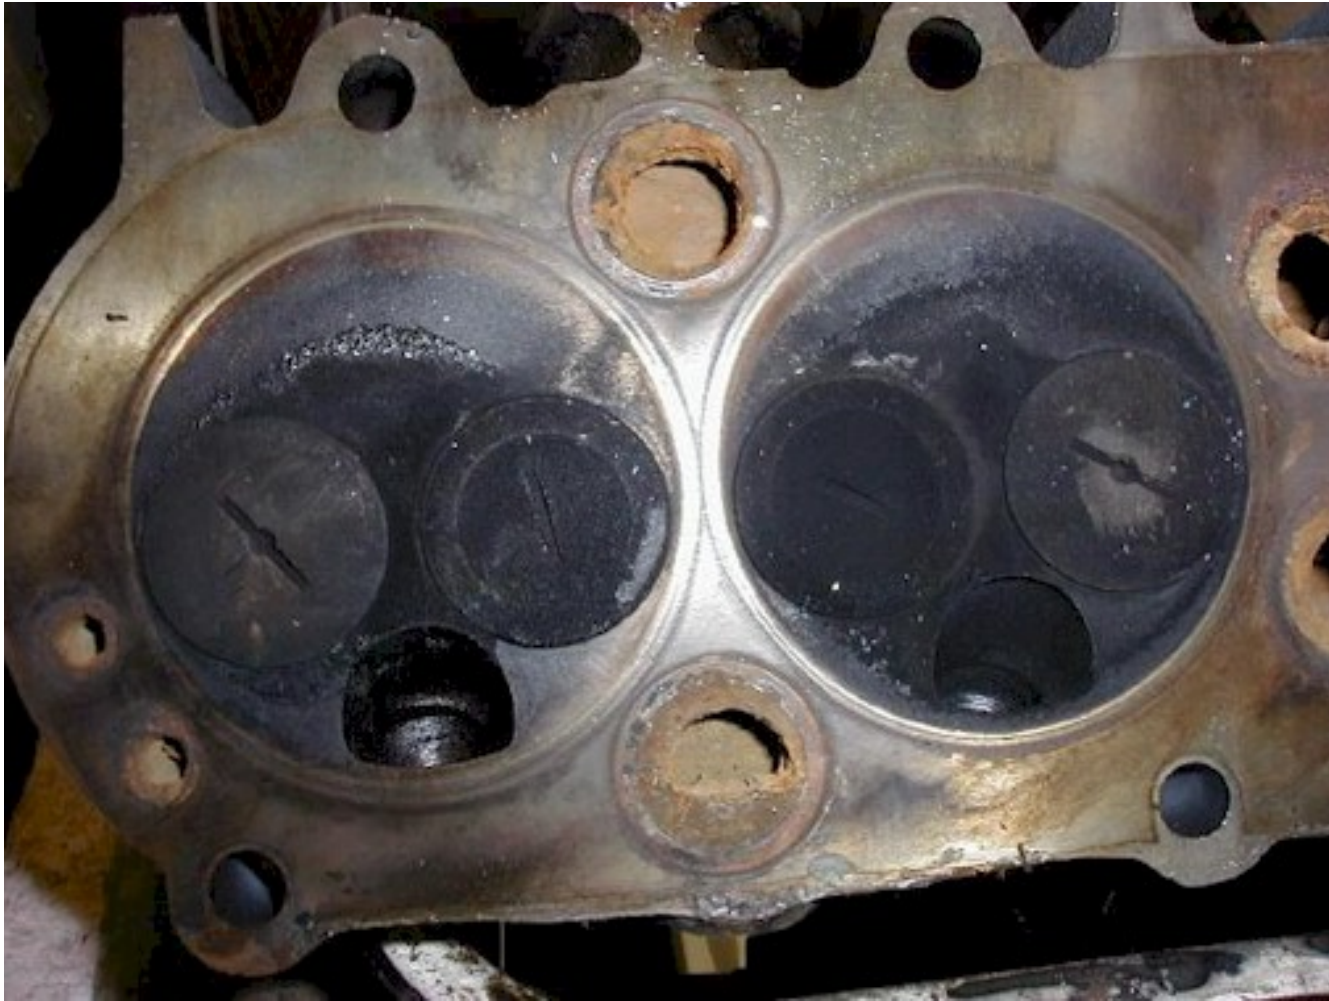
This is how the head looked when it was removed. You can see considerable carbon build up. Too much build up can cause problems, such as pre-ignition, caused by the carbon getting hot enough to ignite the fuel mixture before the plug fires. Pieces of the carbon can break loose and get under the exhaust valve. This can cause the valve to burn or be damaged. Too much carbon build up can also cause 'pounding' on acceleration, and can lead to overheating.

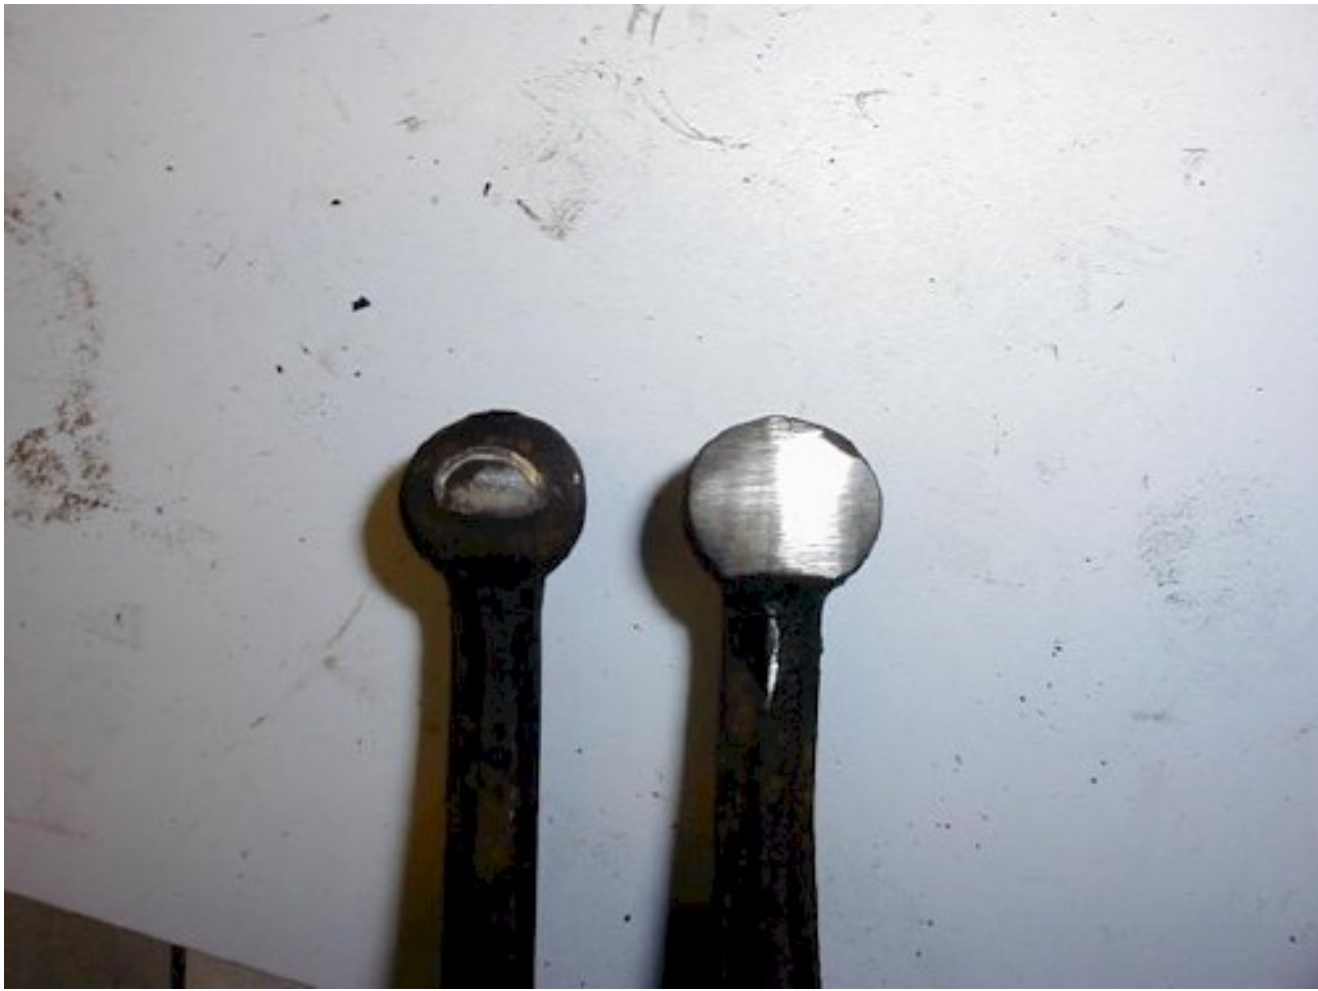
On the left is the face of one rocker that is as removed from the engine. The mark you see is the wear pattern. Let's assume for the sake of discussion that the wear mark is in fact .010 inches deep. This valve would be noisy and we may decide to gage it and readjust. Assuming that we wanted to set this valve to a value of .010 inches and place the flat feeler gage between the top of the valve and the end of the valve stem. We make this adjustment and to our amazement the valve is now much more noisier. Why, because the combined value of the assumed correct setting and the addition gouge in the lifter has in fact become an actual .020 setting. The point of this discussion is to point out the necessity of grinding the rocker arm faces when a head is rebuilt. The rocker arm face on the right has been ground so that now a feeler gage placed under the arm and on top of the stem would result in an actual setting of .010.
