**Chevrolet Four Cylinder
Engine Rebuild Discussion**

From the chat site of:
The Vintage Chevrolet Club
Of America

Teacher: Raymond Holland

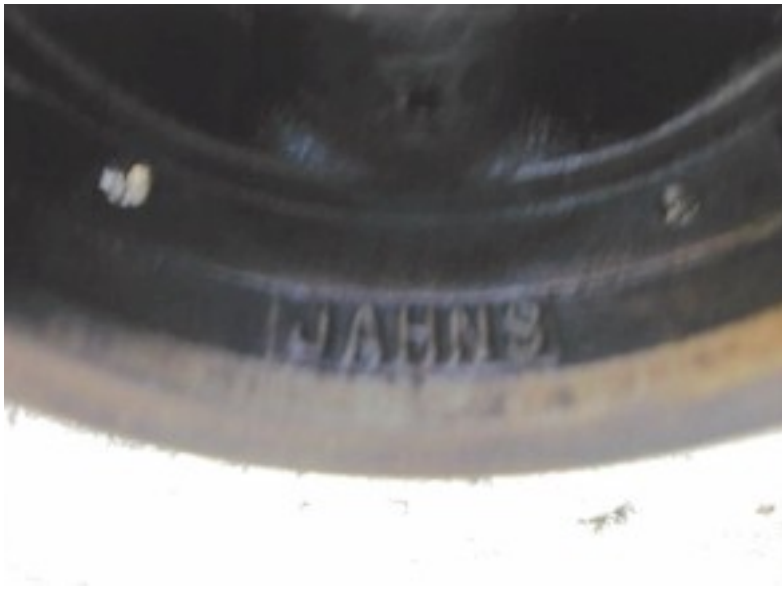
I think that is a firm indicator of the manufacturer.

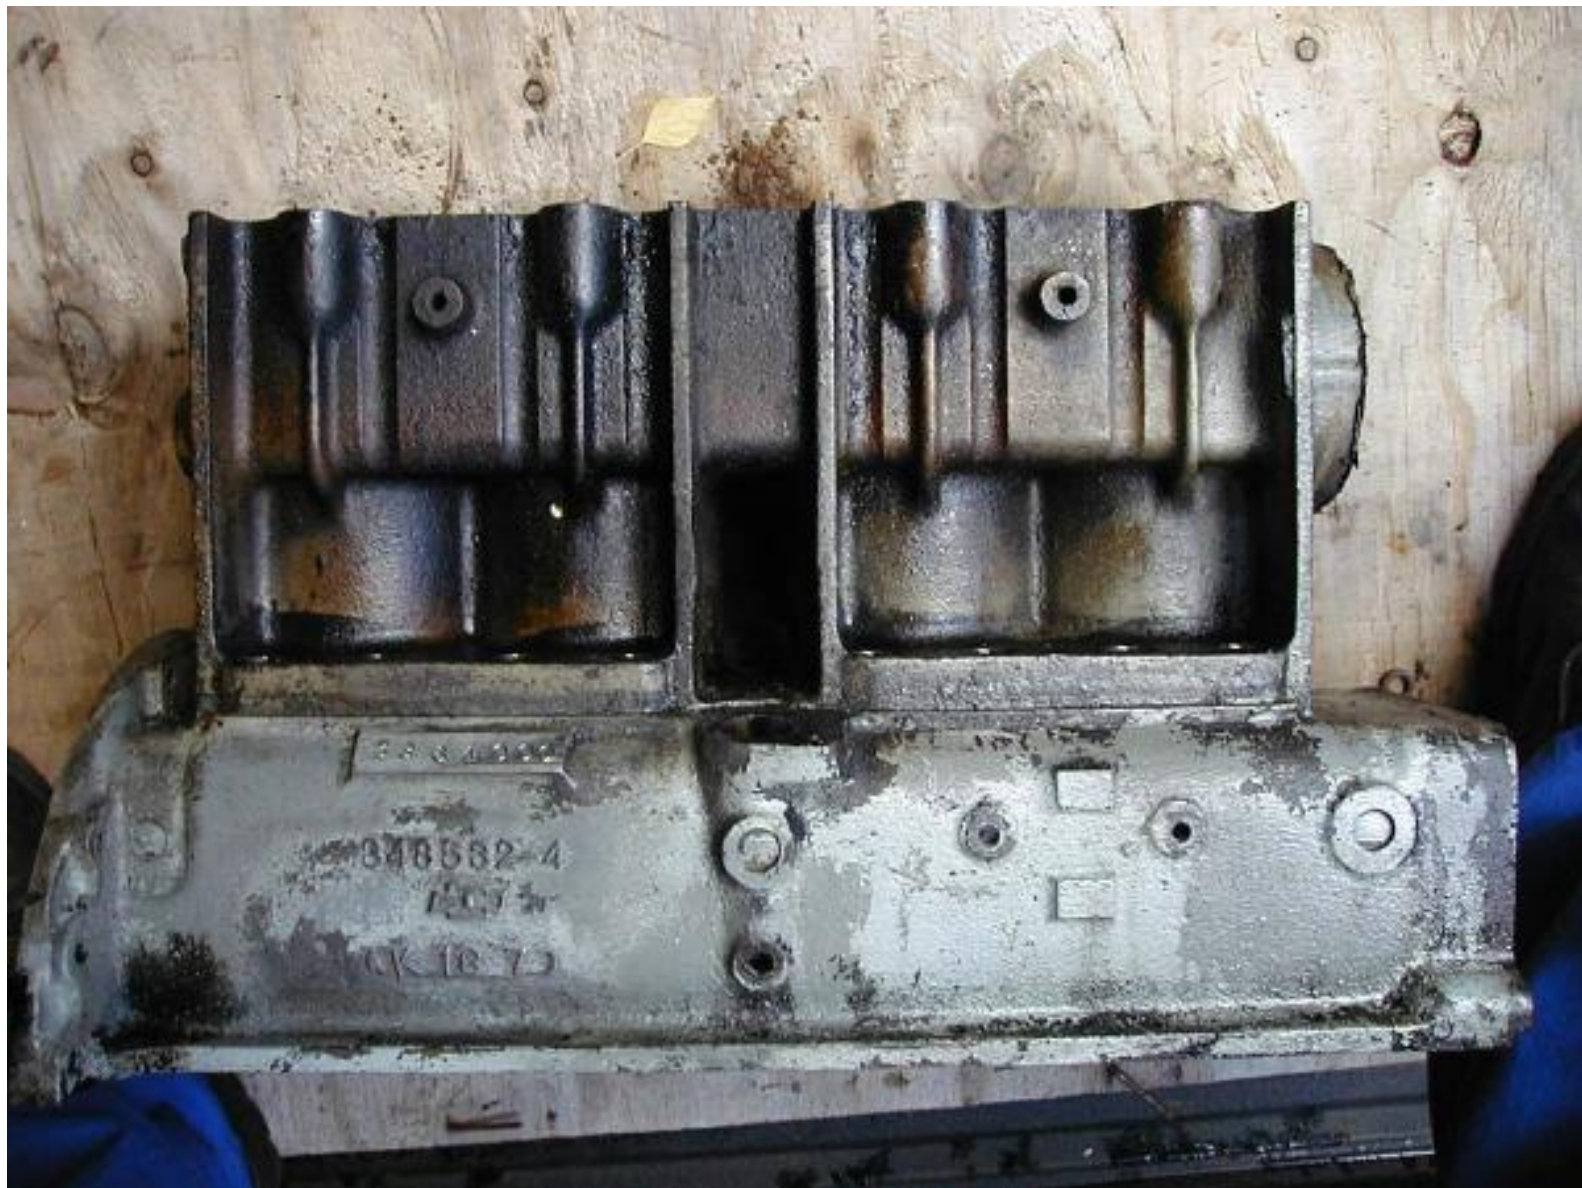
Hot tanking the block turned out to be difficult too. That is to get it thoroughly clean. When the rear soft plug was removed it took a drill bit to remove the 'crud' packed around #4 in the water passages. It was obvious that no water had circled #4 in many years. The reservoirs above the front and rear mains were packed with black gook. It is even more obvious that this car was not well maintained and now I even question the engine builder.

From the picture, which is the right side (passenger), you can easily see the discoloration around #3 and #4 as was mentioned in an earlier post. What, with the plugged water passages, poor oil changing practices, and perhaps the bad piston, it is no wonder that I decided to tear this engine down for inspection.

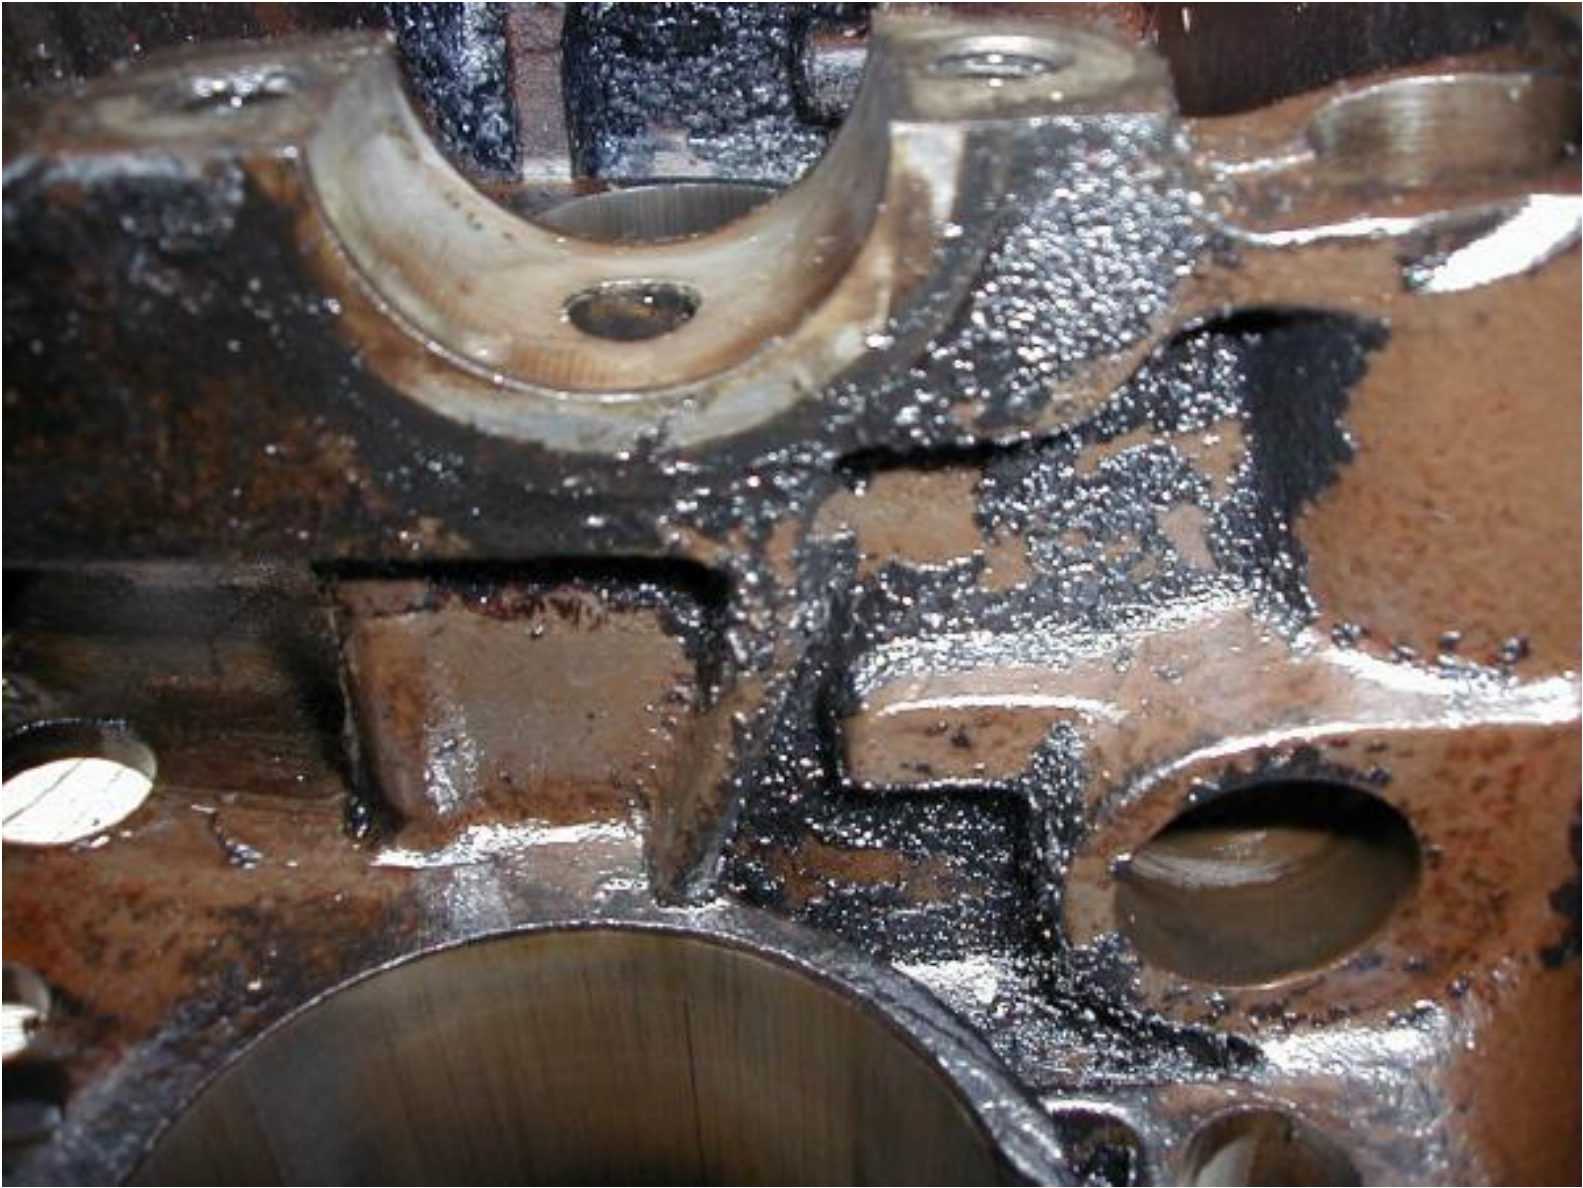
Here is a view of the 'crud' on the center main bearing support. This same material was all over the inside of the engine and in all the reservoirs.

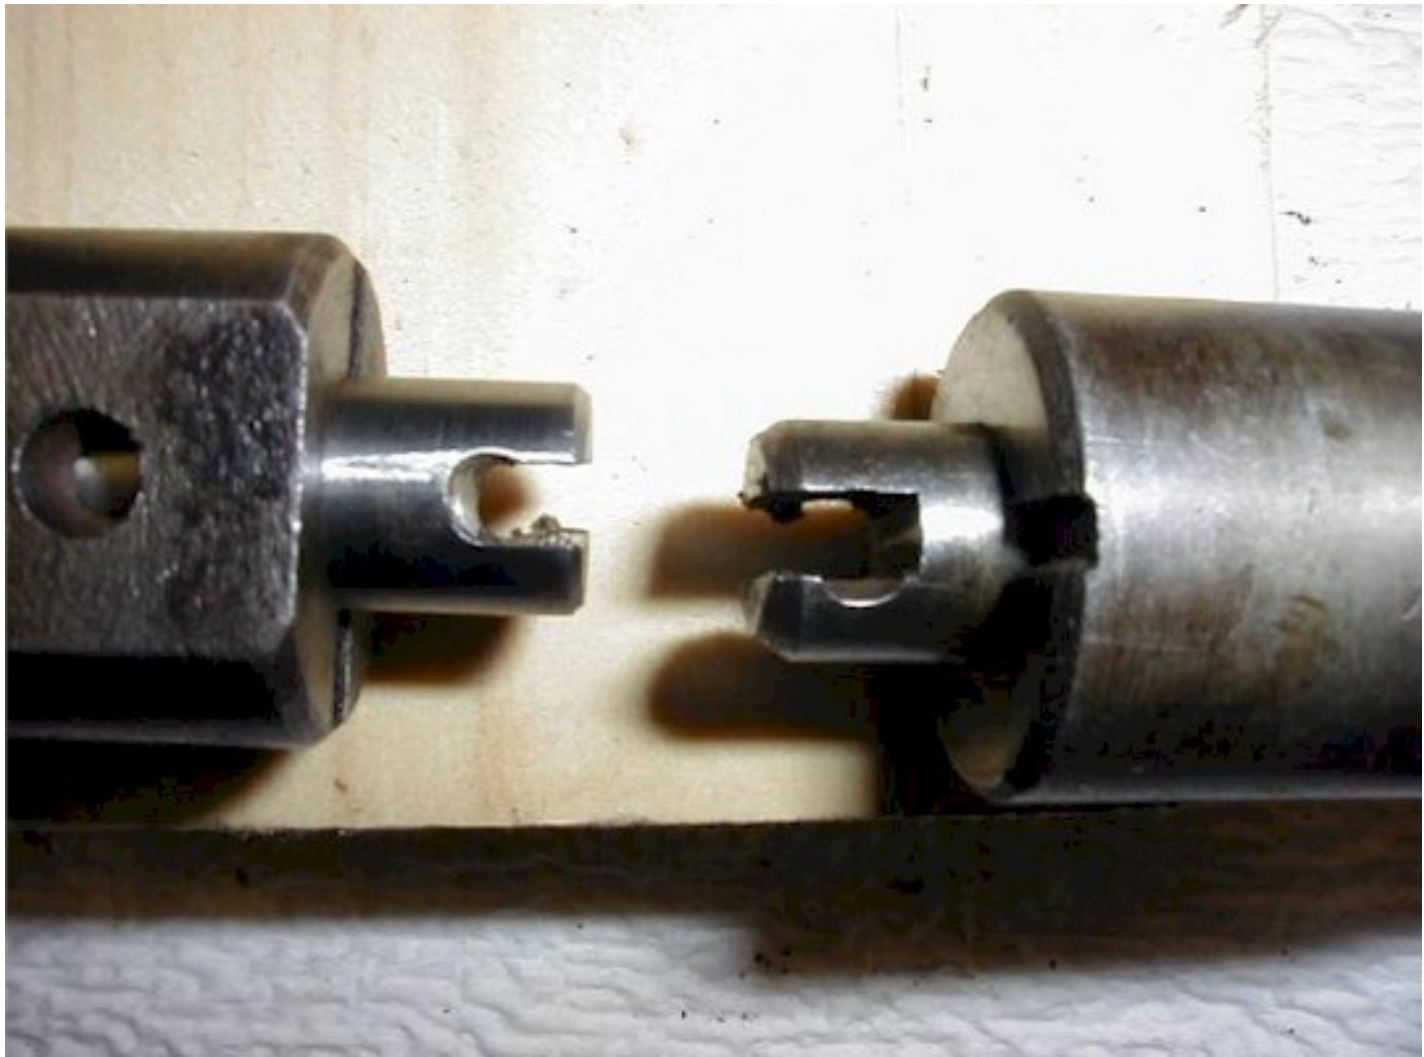
Ever inspect your OE pump and discover what appears to be abnormal wear on the drive end? Well, that is not wear. That groove is put there to 'hook' the distributor and make the two shafts operate as one. Otherwise the distributor would jump up and down as it rotated. The OE pump is on the right and the NEW pump is on the left.

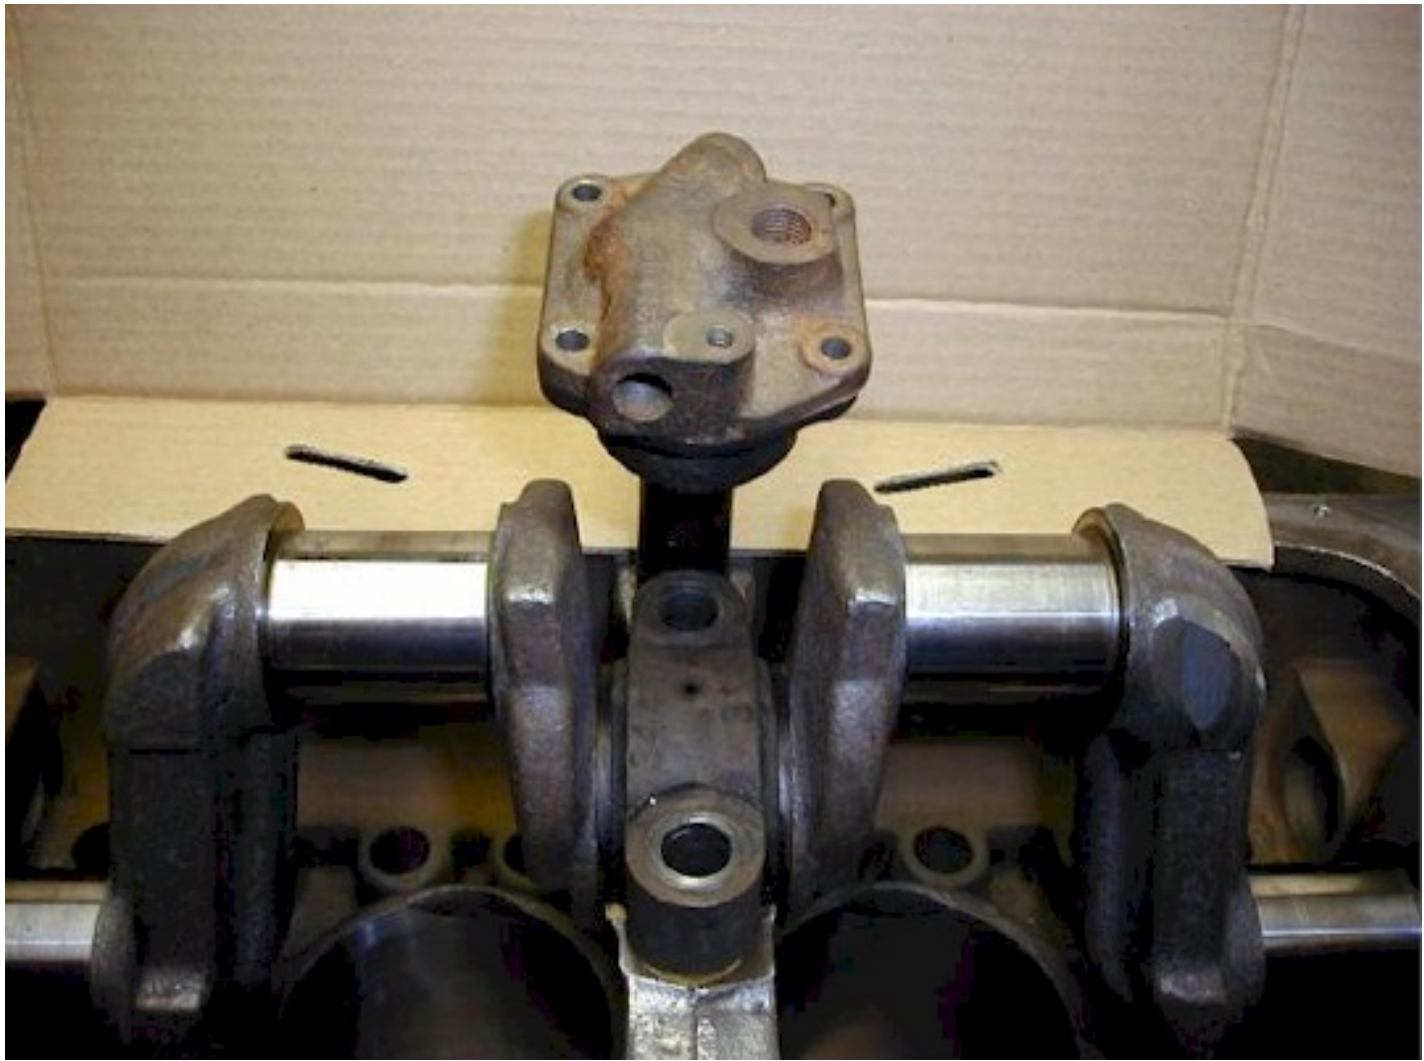
This is a test fitting to insure that the crank throws will not hit the new pump. Notice even the cap bolts are not installed. Everything looks good at this point. Notice that the pump extends much lower into the pan. This is a major advantage, as a portion will actually be submerged in the sump oil.

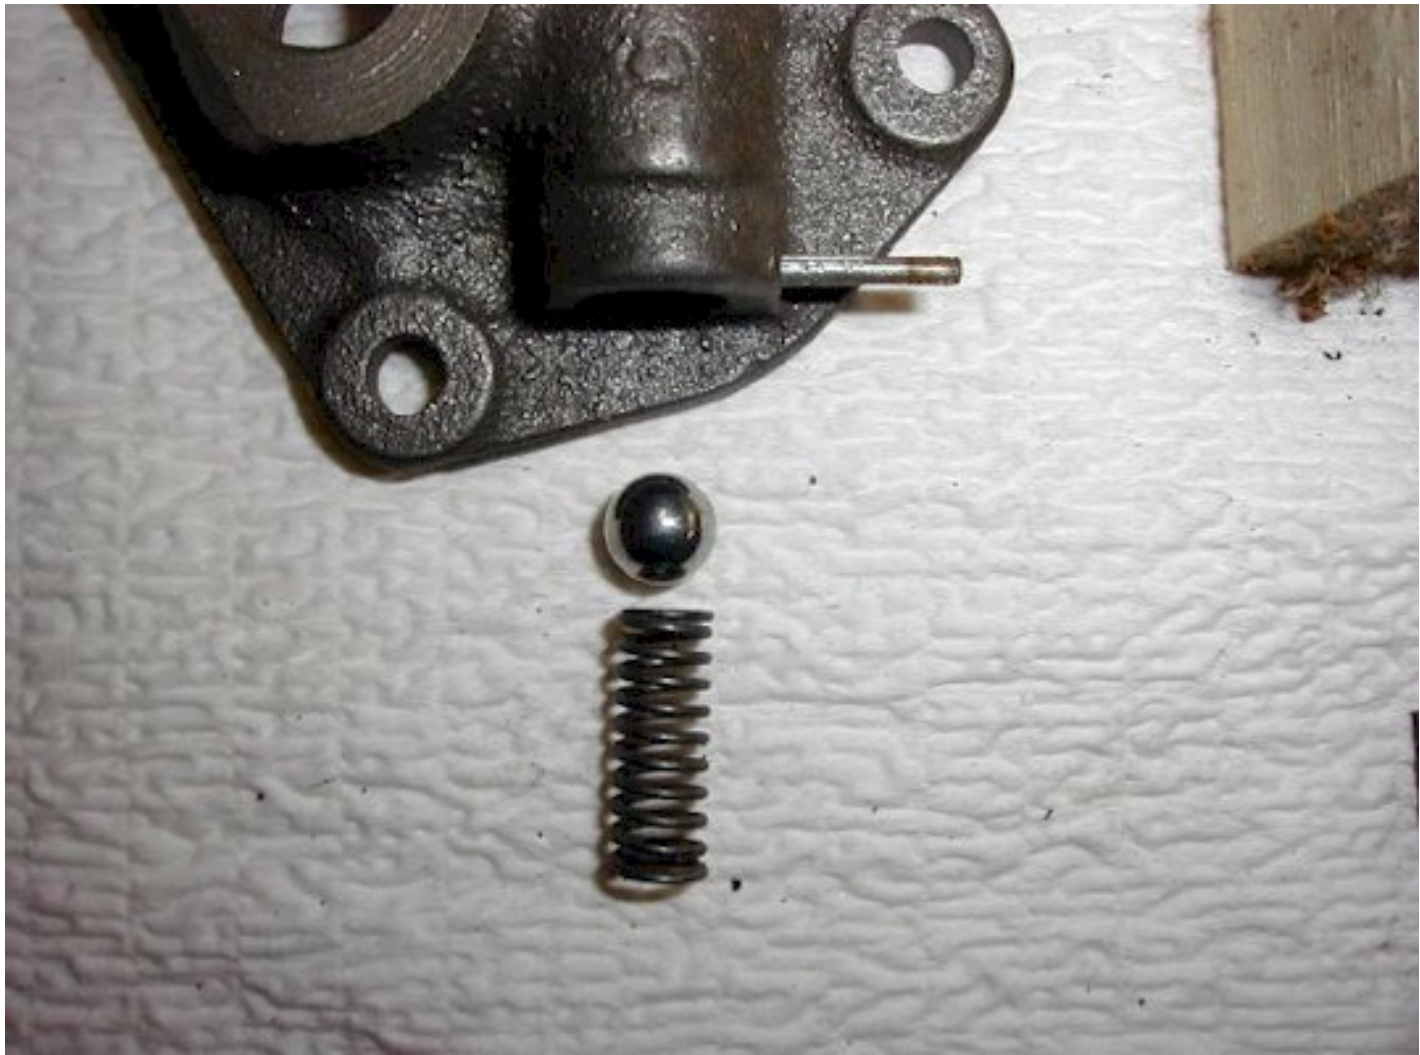
I have disassembled the pressure regulator valve to insure thorough cleaning. Never did find out what the exact release pressure was on this pump, but it really doesn't matter. Pressure could be adjusted by cutting some of the spring off (less pressure) or stretching it (more pressure) or by replacing the spring.

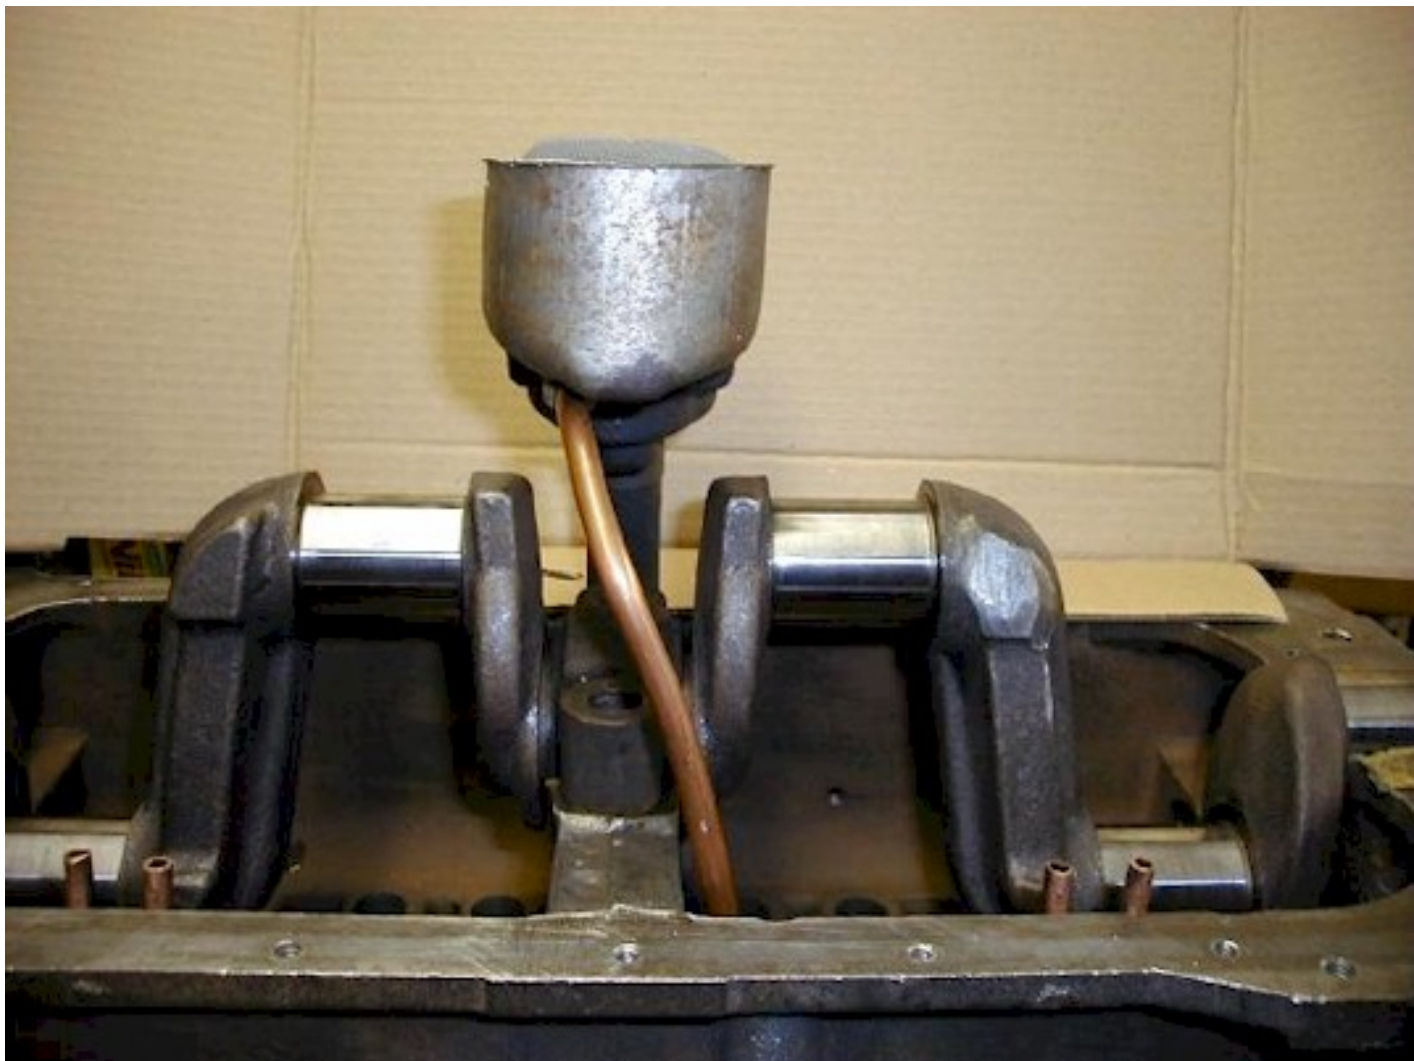
More test runs to insure I could run the pressure line and not have it interfere with the crank throws. Fittings have to be matched to make the pipe fit. First fitting of the pickup shroud to insure clearance with the oil pan.

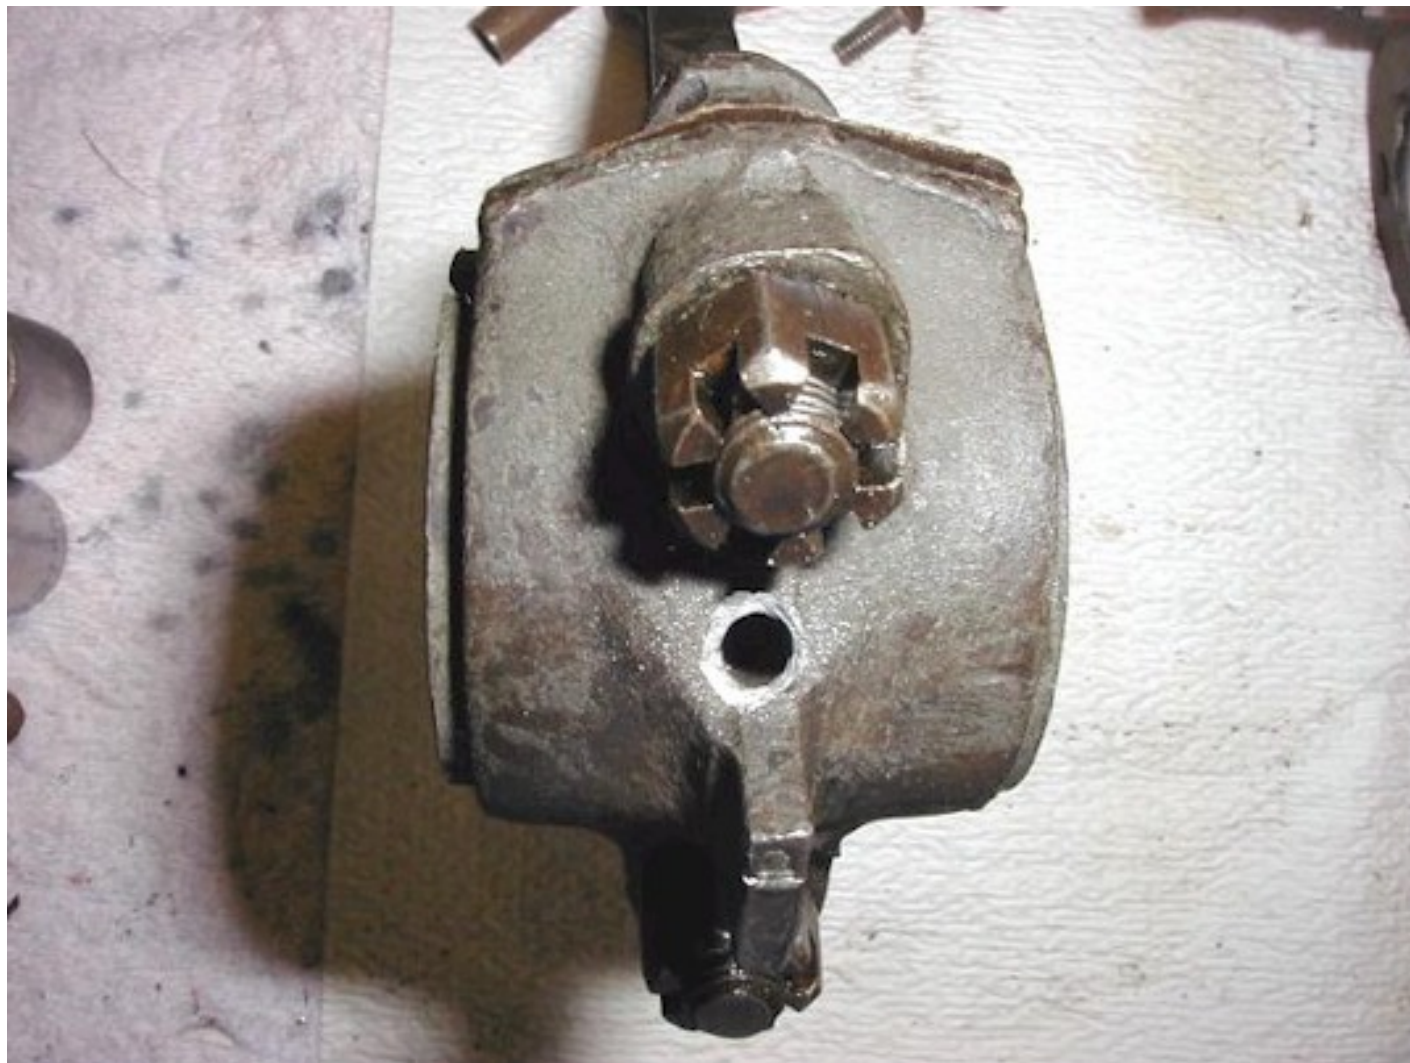
Notice on the picture the hole in the rod-bearing cap. This is the entrance hole for the oil. The tang is located in the picture just below the hole. The hole has been chamfered

slightly to funnel more oil into the bearing.

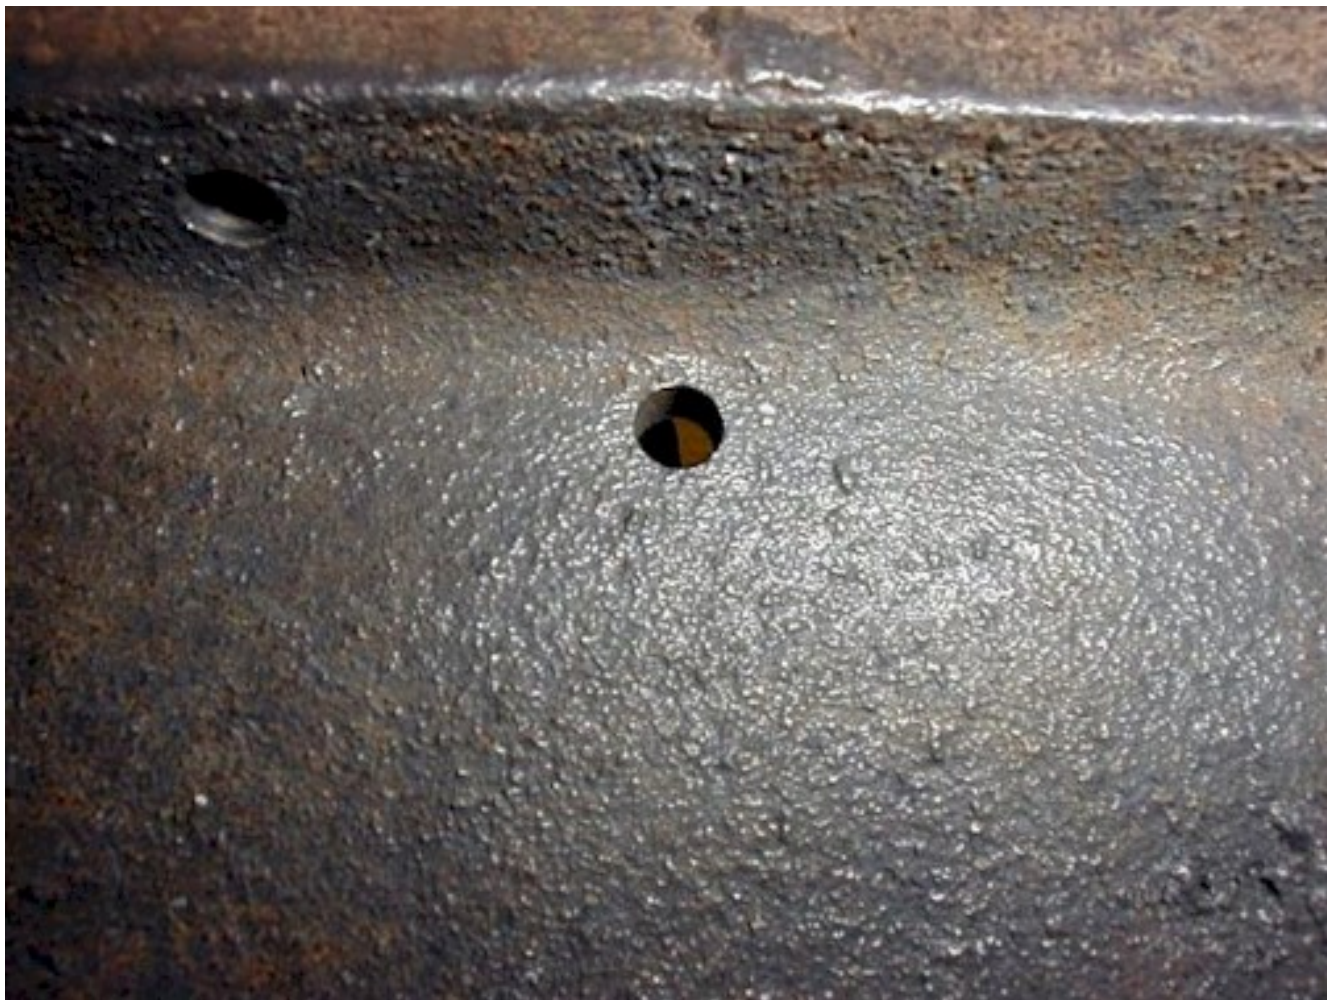
This is one of the attachment points in the block to secure two of the pipes. Notice that this is a through hole in the block. Any time you have a hole that goes through the block you have an excellent chance for an oil leak.

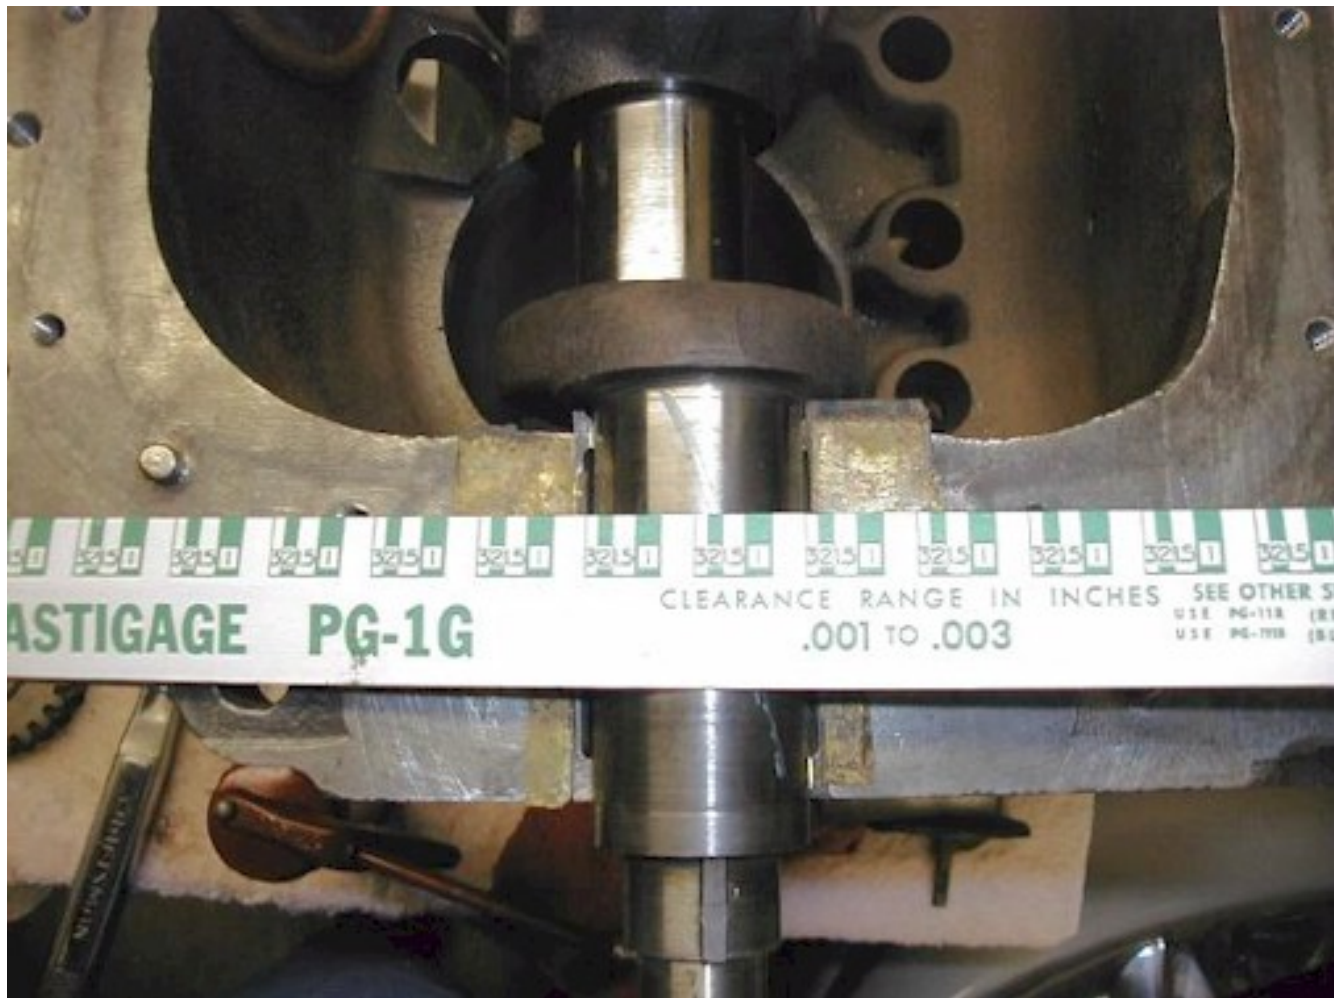
This is the front main. The reading here is also about .002+. This bearing still has a number of shims left on each side. However, because the center and rear are out of shims the next disassembly will call for a complete rebuild.

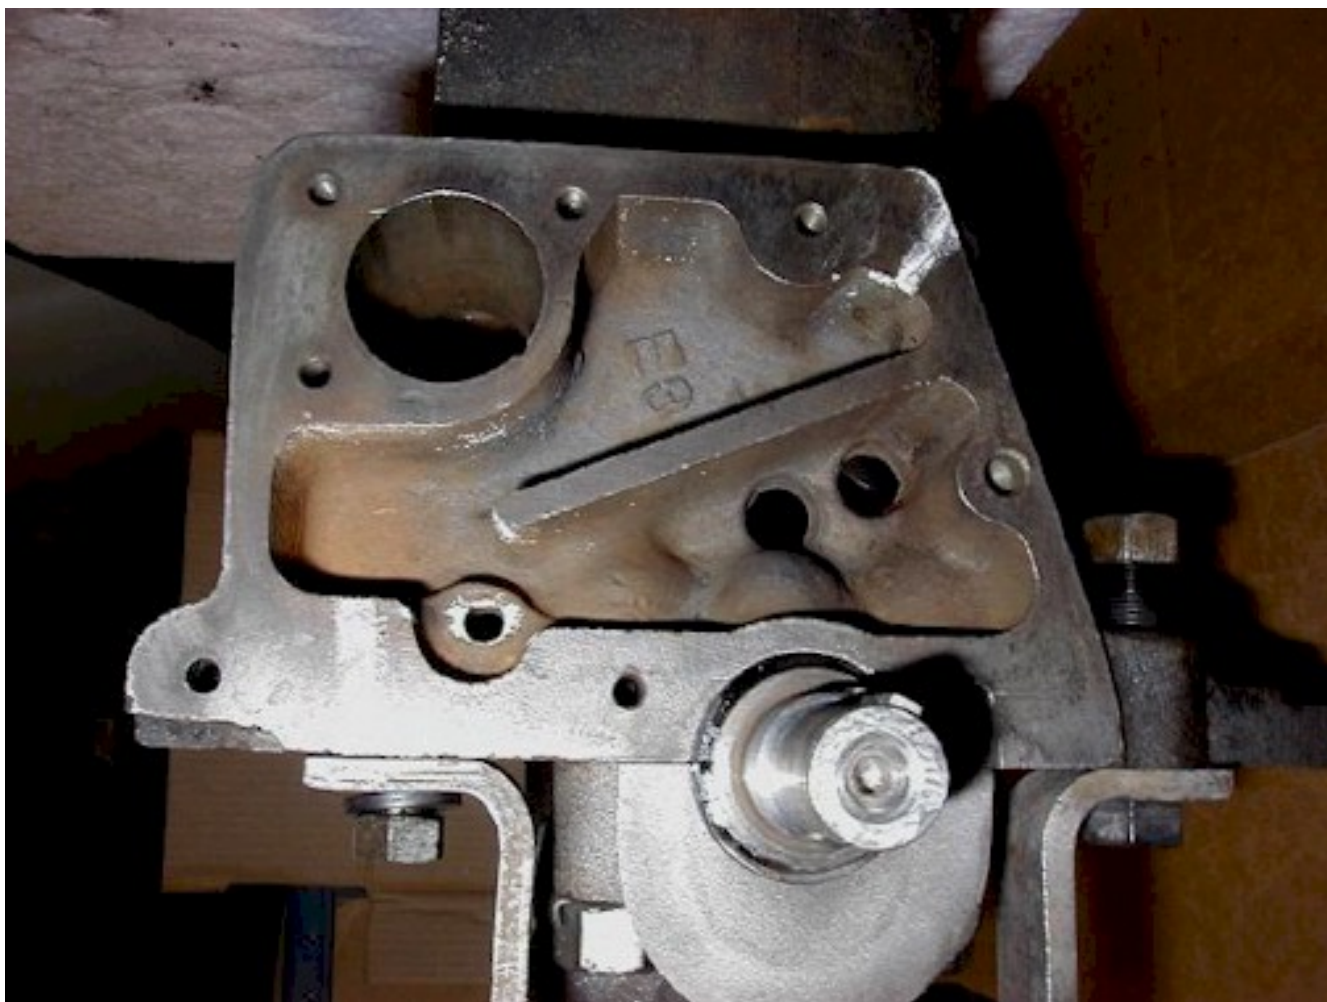
If you look directly above the crank you will observe two holes close together. These holes go through to the inside of the block. These two holes are the main entry for oil into this cavity. The single hole marked with chalk in the lower left is the return hole back to the pan/sump. In the extreme upper right of the picture is an entrance hole from the outside of the block. This hole is where the end of the draft tube from the carburetor is attached.

More on this tube later, but this is where the burned gasses are scavenged and directed back into the intake through the carburetor. In the lower left corner marked by chalk is the location of one motor mount bolt. This is a **through** bolt. That is, it is threaded into this cavity. If you have an oil leak at the front of the engine that is driving you crazy, remove this bolt, coat with the gas tank sealer (yellow snot) and replace. Notice that at about 4:30 on the cam bearing is an oil groove. Splash oil from inside the engine and from the reservoir above the cam bearing can traverse this groove and will end up past the gear cover plate to lubricate the cam gears. Other than the small amount of oil that gets by the front main bearing this is the only means of lubrication for the cam gears.

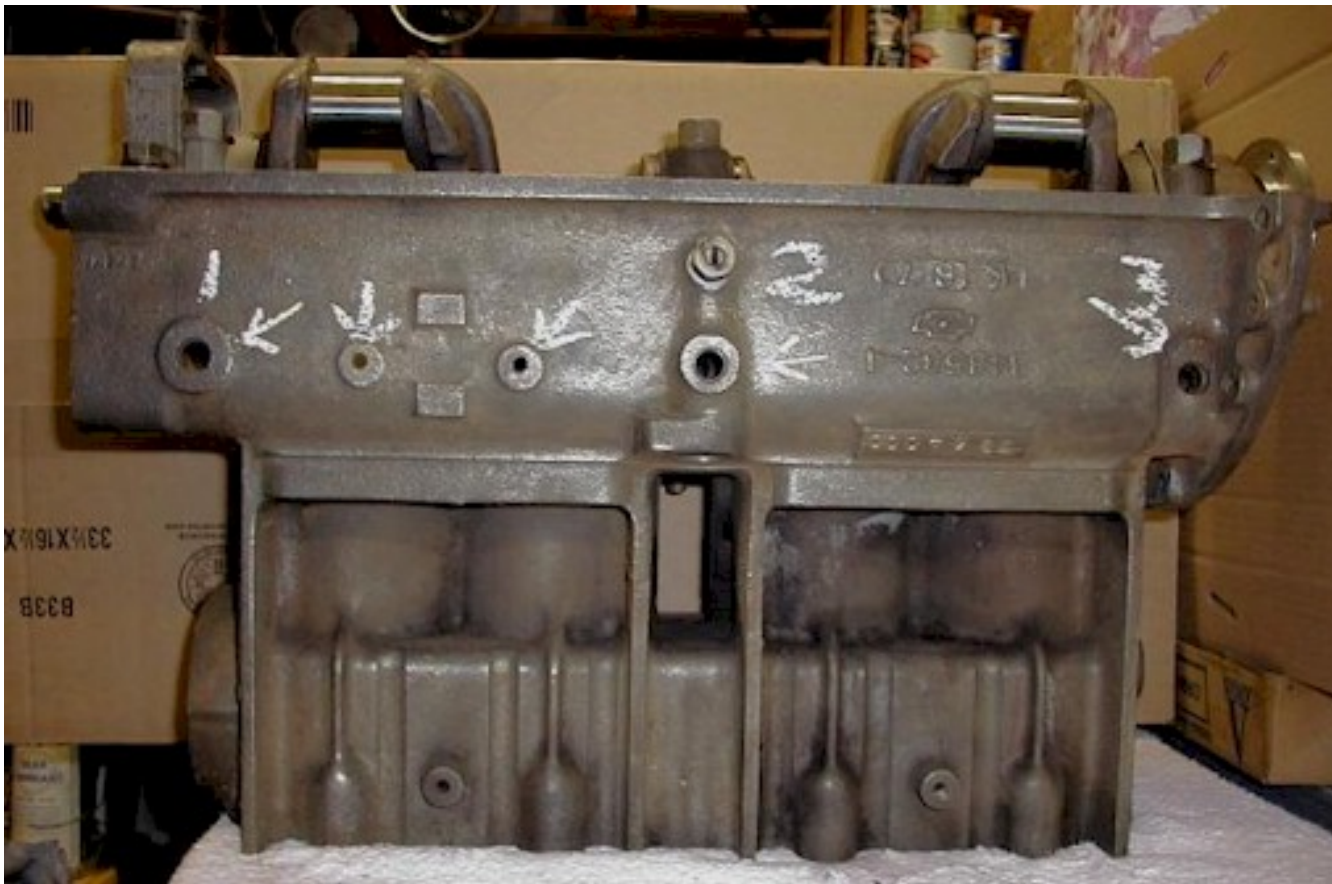
The locations marked 1, 2, & 3 in chalk are soft plug locations. However, water is not behind them. These are the access holes that are drilled from the outside through the cam bearings and all the way into the reservoirs for each cam bearing. It is necessary to

remove these soft plugs before the block is hot tanked. In the cleaning process a wire brush can be inserted all the way into the reservoirs for a good thorough cleaning.

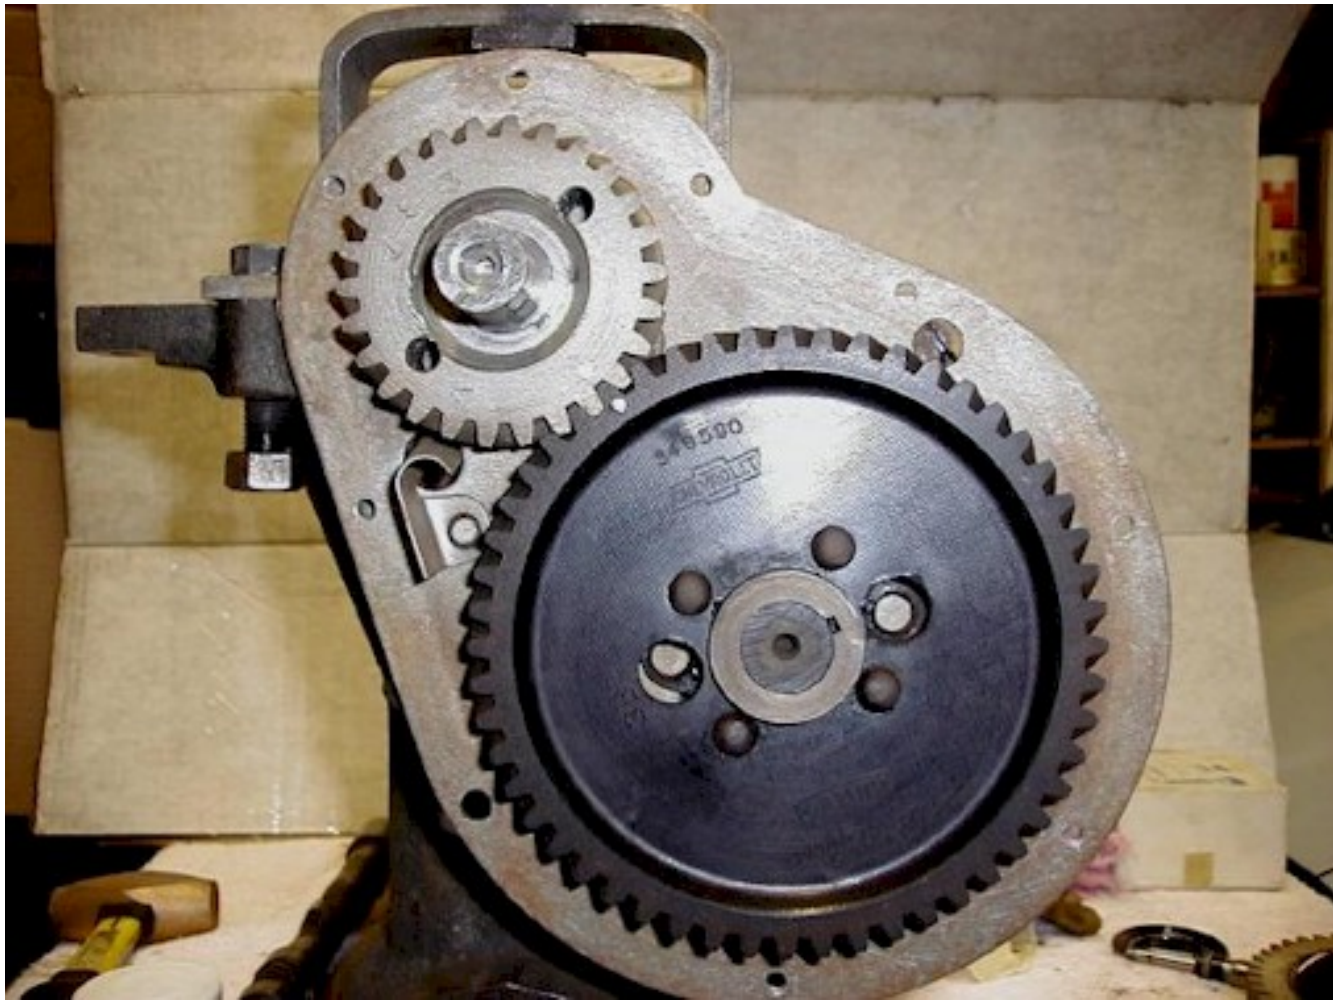
After a good coating of both the camshaft and the bearing surfaces in the block with assembly lubrication, the cam is inserted into the block. This application uses a metal crank gear and a fiber cam gear.

In 1927 Chevrolet reversed the normal composition of the crank and cam gears in the engines. For '27 the cam gear was metal and the crank gear was fiber. Another confusing issue was the use of a different number of teeth in each gear. For 1927 ONLY, the tooth count was 46 cam and 23 crank. All other gear sets were 52 cam and 26 crank. The '27 gear sets may be used in the '26 and '28 engines IF USED AS A SET ONLY.

Here is where we start getting in trouble. The mating mark on the cam gear is on a TOOTH. The mating mark on the crank gear of course is on the valley or between two teeth. IF YOU HAVE THE AA-AB CHEVROLET REPAIR MANUAL EFFECTIVE FEBRUARY 1ST, 1928, GO IMMEDIATELY TO PAGE 42 AND CORRECT FIGURE 42 FOR THE SERIES AB. The assembly marks are backward.

To make matters worse, and has been pointed out in this Chevy Chatter before, many aftermarket fiber cam gears are mismarked. If you have an OEM gear to copy the mark from, use it.

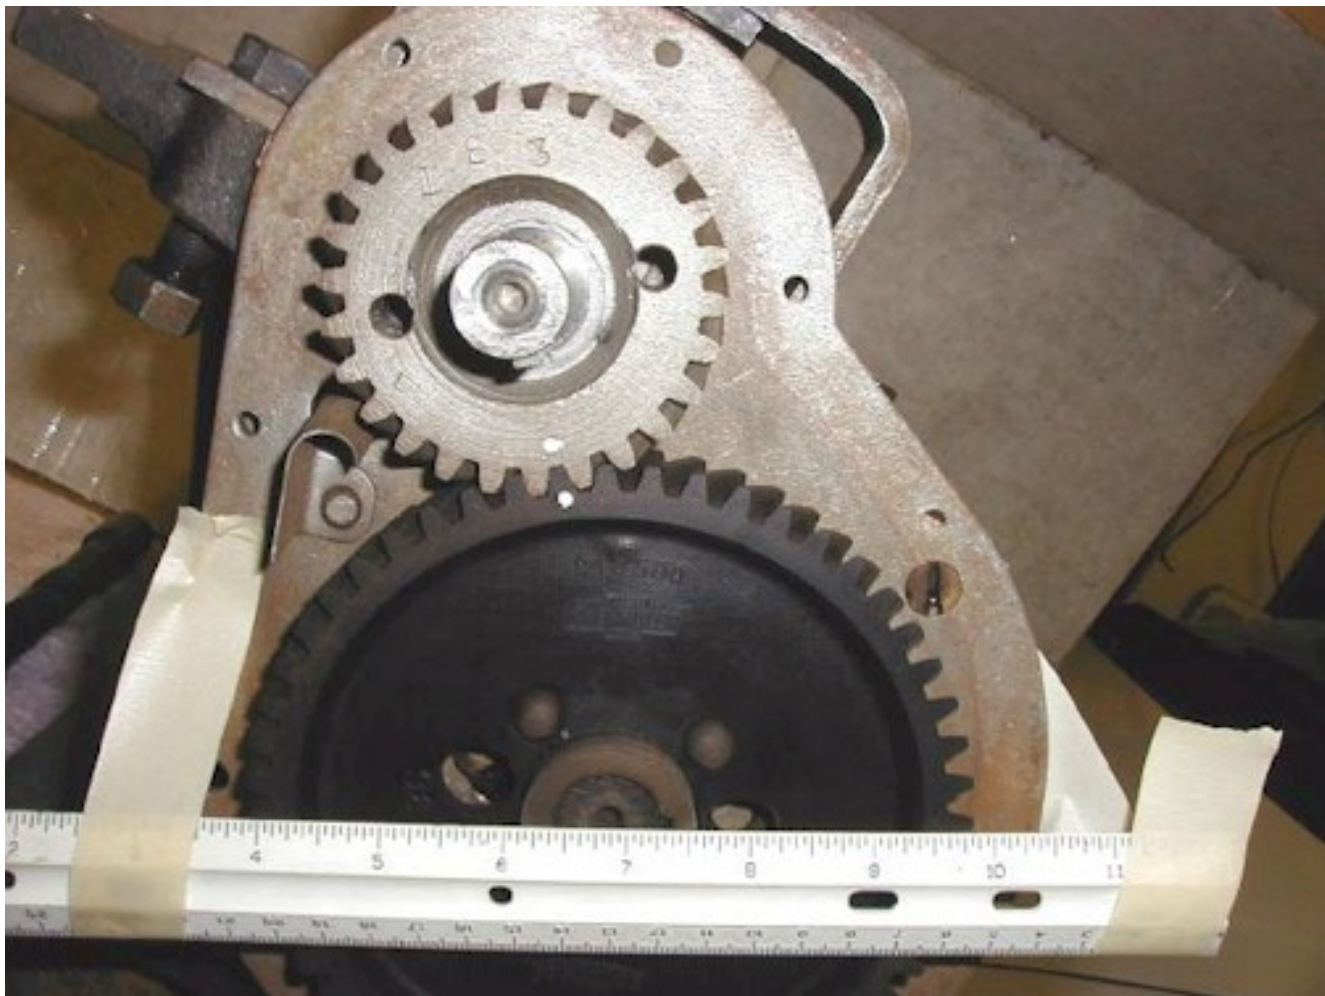
If you don't have an OEM gear you can construct a line through the center of the cam gear and in line with the keyway. Then count 15 teeth counterclockwise to locate the mating mark on the cam gear.

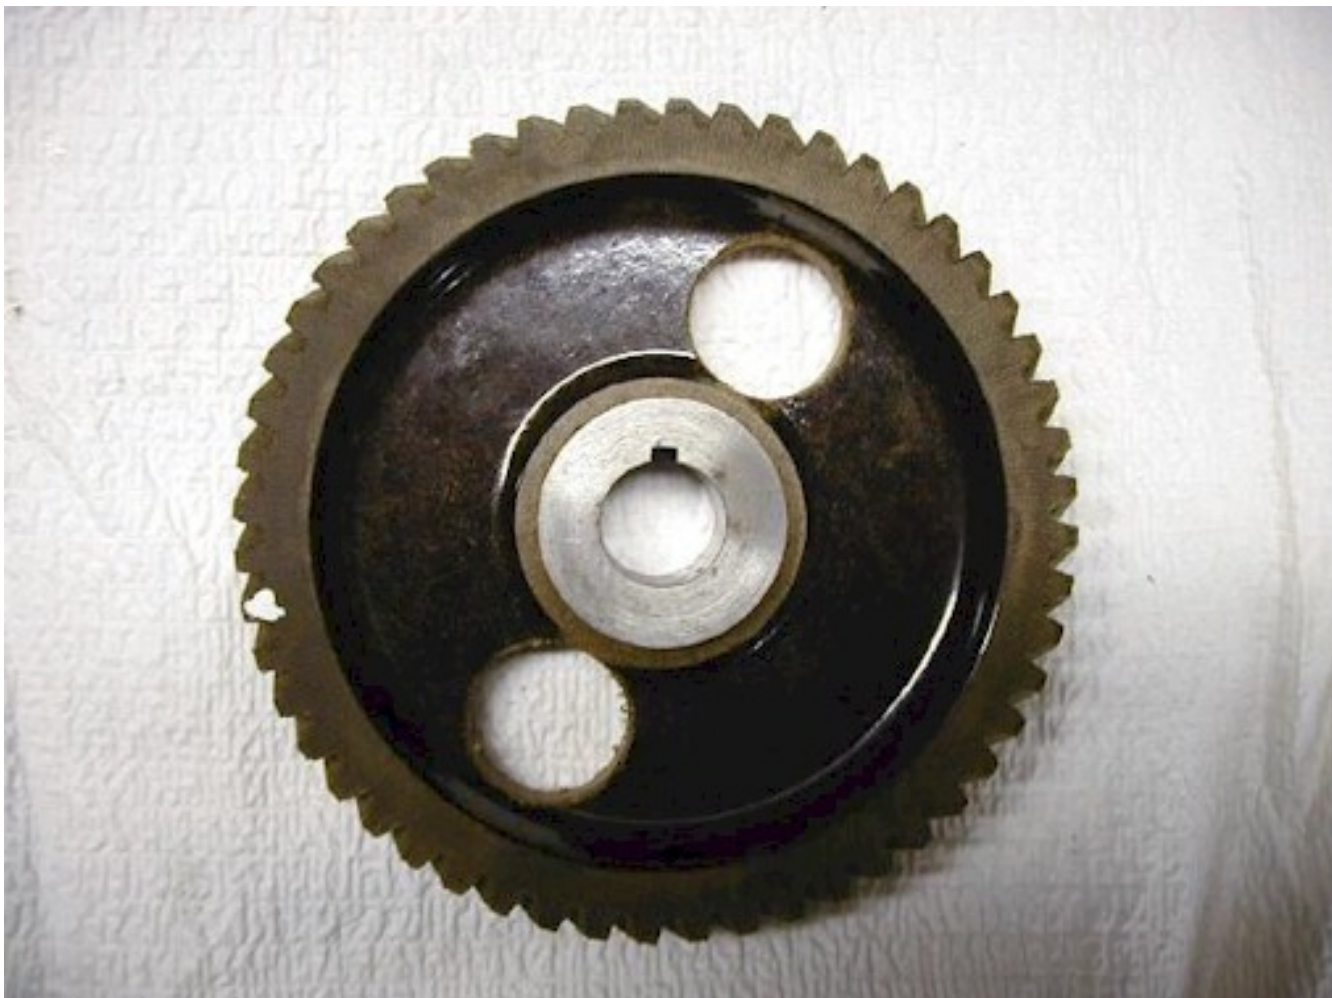
This is an after market fiber 13/16 gear for use with the steel crank gear in either the '27 or '28 if used with the steel gear. This gear was NOT mismarked. It wasn't marked at all. The mark you see added was based on a transfer from an OEM gear.
