**Chevrolet Four Cylinder
Engine Rebuild Discussion**

From the chat site of:
The Vintage Chevrolet Club
Of America

Teacher: Raymond Holland

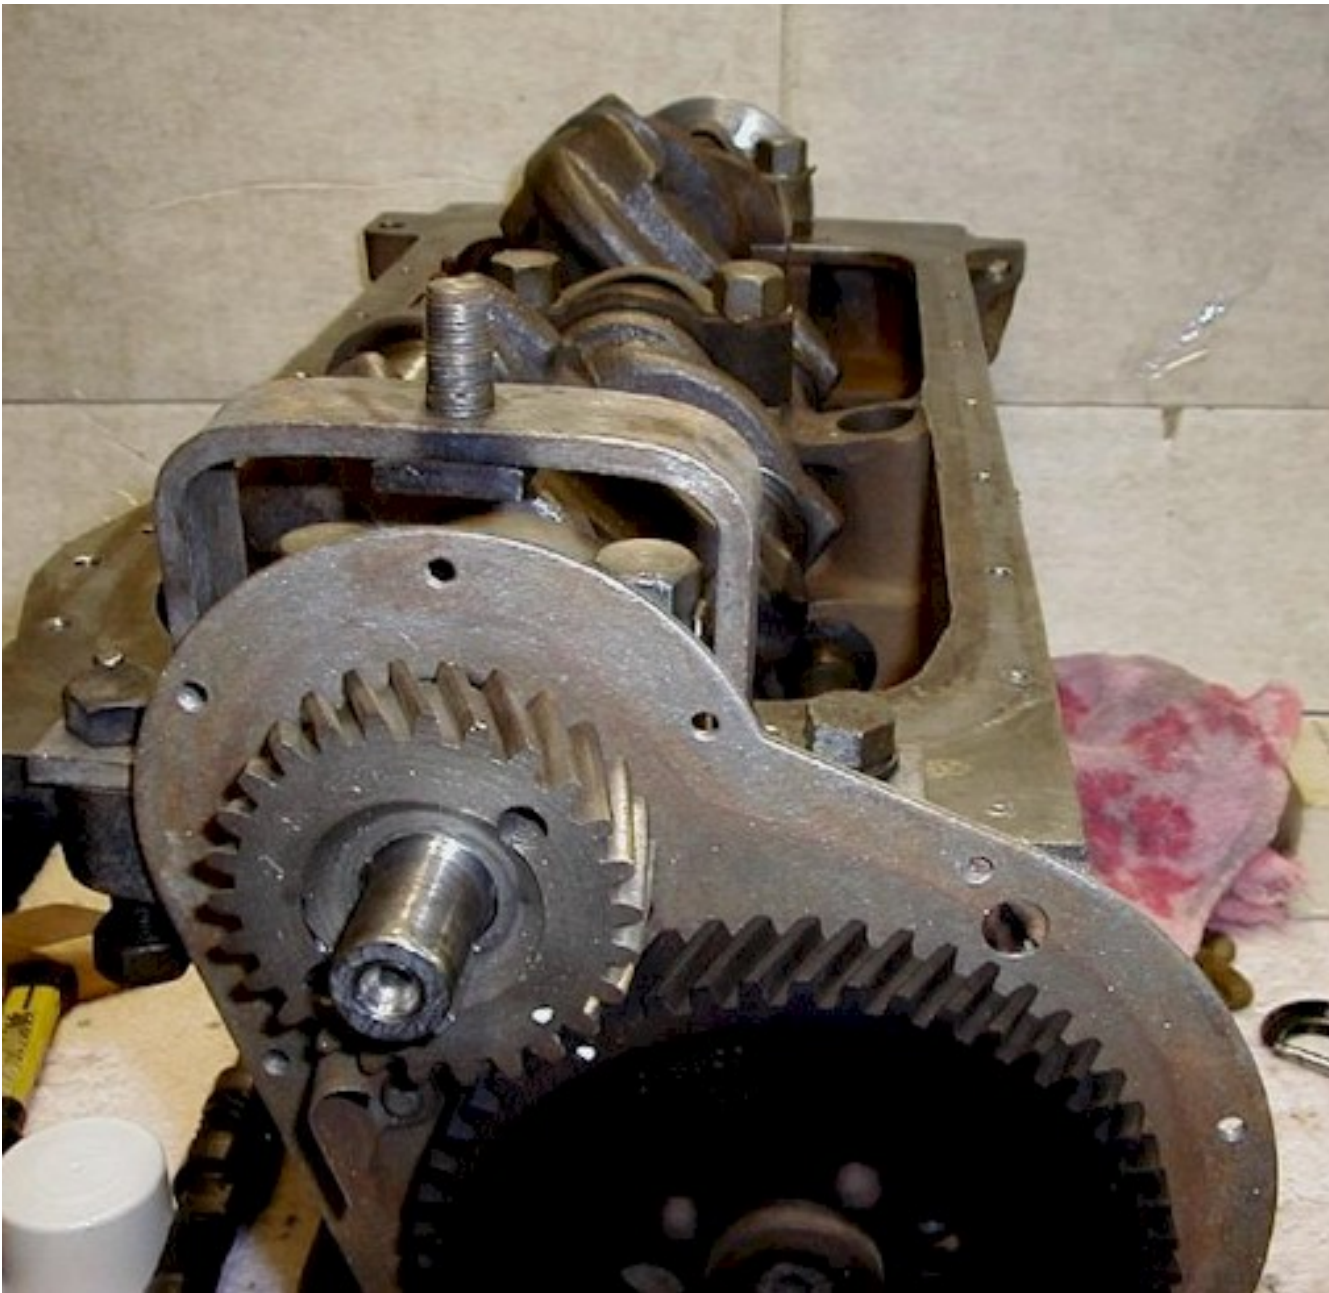
Study this picture closely. You will see that the marks on the cam and crank gear are 'mated'. Now look at the location of the crankshaft. Notice that the lobes are not vertical. The point I am making is that this is not the TDC (top dead center) that would be used for the installation and registration of the distributor. For years it has been difficult to convince people that the mating marks are FOR ASSEMBLY ONLY and have absolutely no relation to the TIMING of the engine. It is easy to see from the picture that if you looked through the hole in the flywheel cover you would NOT see the timing mark. After the timing gear cover is installed, so you can't see the marks, is the time to place #1 cylinder at TDC, with both valves closed, and then install and time the distributor.

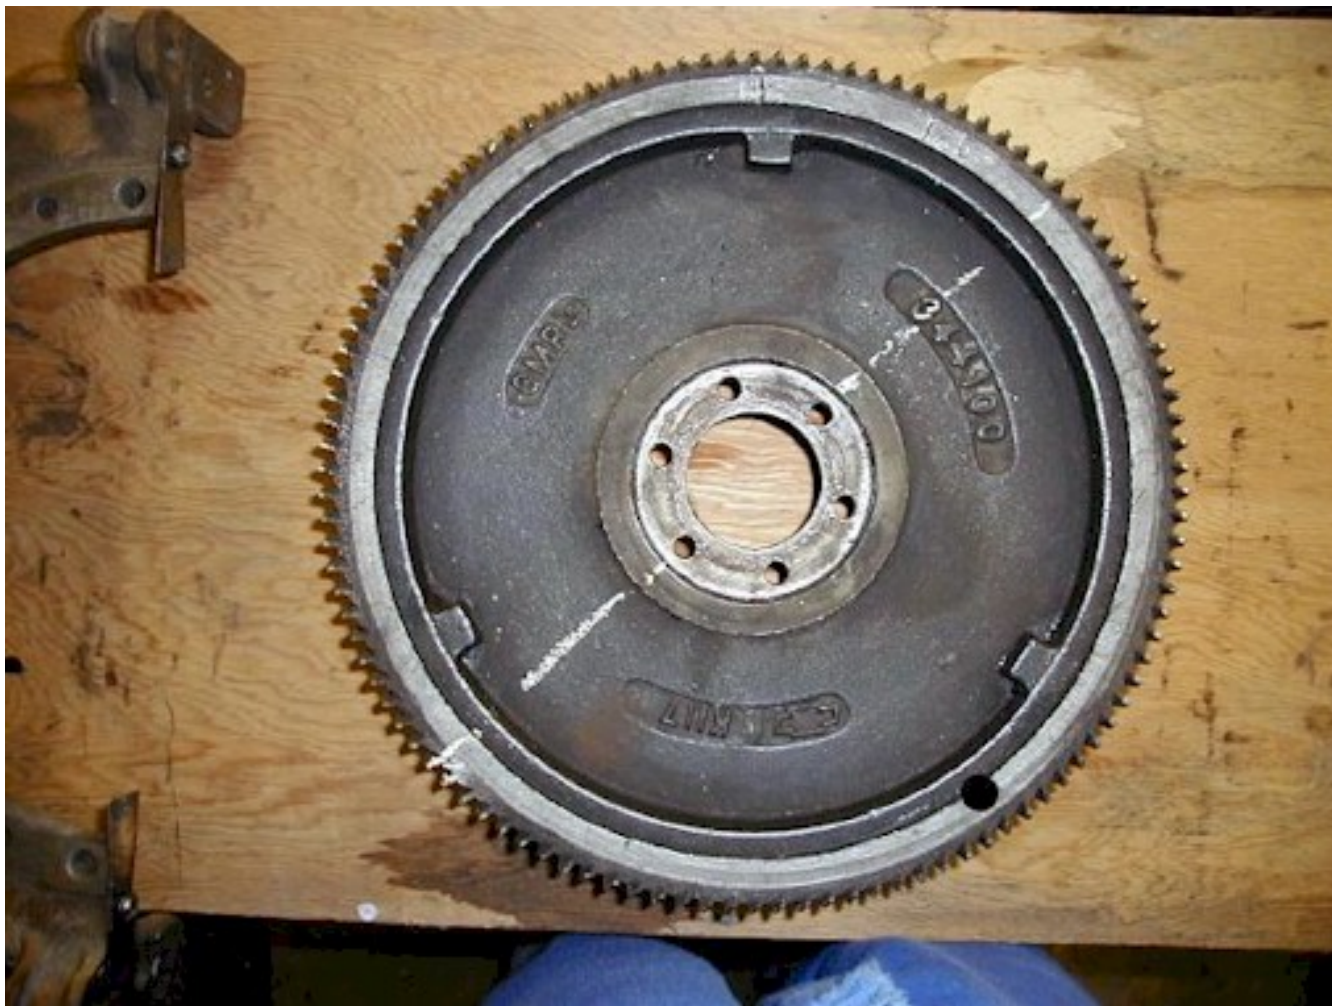
We need to install the flywheel now because it is the right time in the sequence of assembly, and because we can use it to turn the crankshaft much easier. After a good cleaning and inspection it was determined that there were two locations around the ring-gear teeth that were damaged. When a 4-cylinder engine is switched off it comes to rest in either of two locations. It can stop with #1 & #4 pistons up or with #2 & #3 pistons up. When the starter is engaged then one or the other of these locations on the ring-gear meet with the starter Bendix drive gear. That is why we have two specific locations for wear and not uniform wear around the circumference. Ideally, we would replace the ring-gear as this is an easy fix, but they are relatively hard to come by. Therefore, we will try to improve the worn locations. Either a hand file, or if you are proficient with an angle grinder and thin stone, can be used to smooth down the damaged teeth. The idea is to remove any sharp projections and blunt spots that prohibit the gears from meshing smoothly. Caution must be exercised to prevent too much material from being removed.

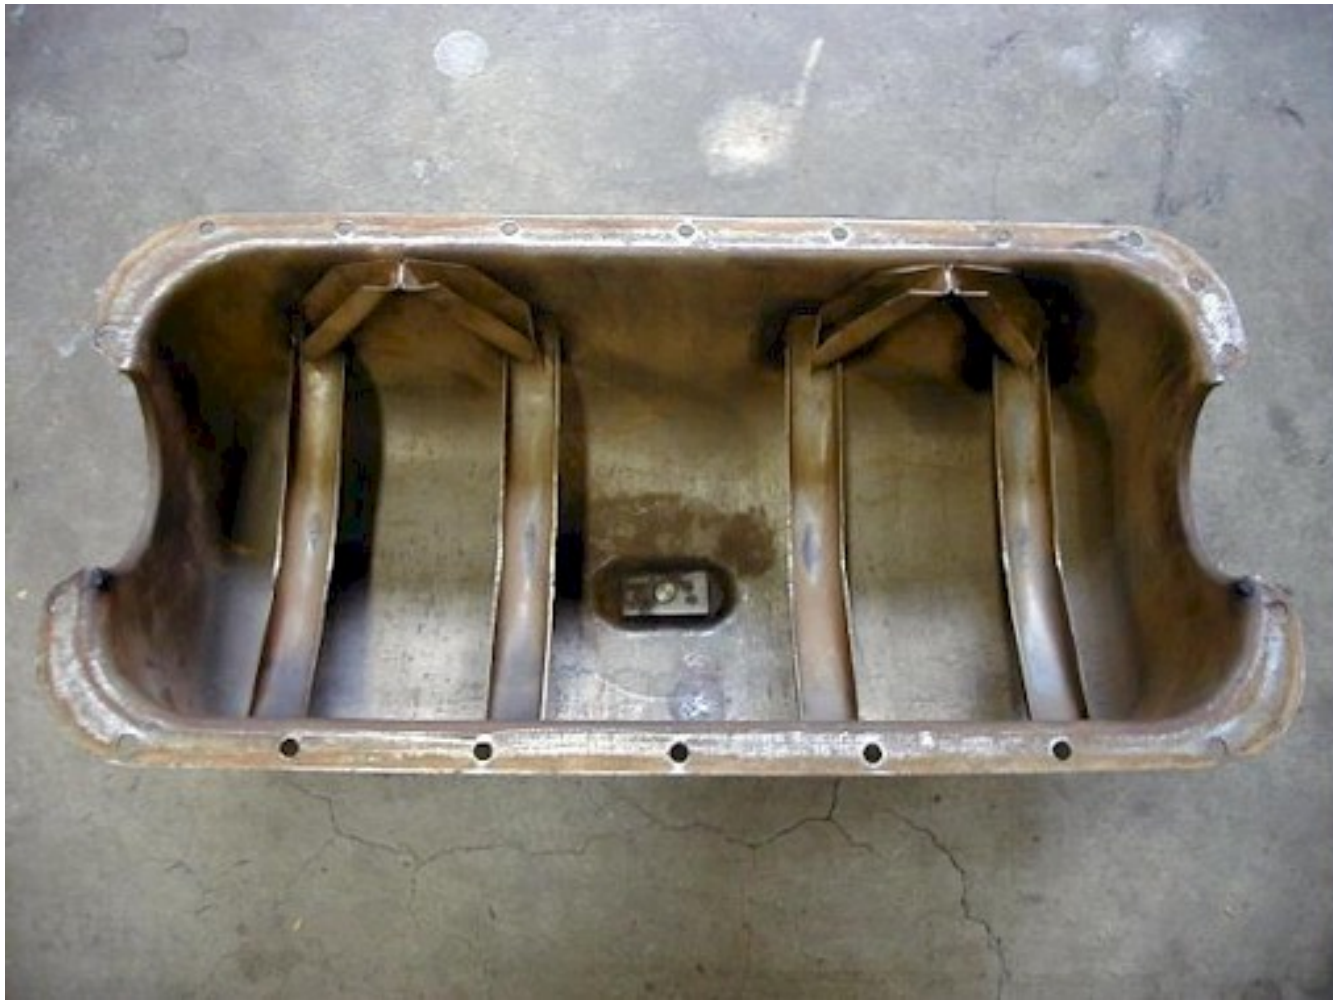
The pan should be inspected for any deformities and most important the inspection of the oil troughs. If this were a major rebuild, where parts from many sources were combined to assemble the engine, we would make some major tests for rod and trough clearance. This could be accomplished by construction of a "JIG" or by filling the troughs with axle grease, installing the pan with correct gaskets, and turning the crank to send each rod through the troughs. The repair manual refers to these troughs as "small oil pans". Ideally, the rod will dip into the troughs 1/16 inch to 3/32 inch. As we are reassembling an engine with basically all the original parts we will not make any tests for the "dip". On the teardown there was no evidence of a problem in this area. We will however, inspect each of the troughs to assure they are firmly affixed at each end and have no visible damage.

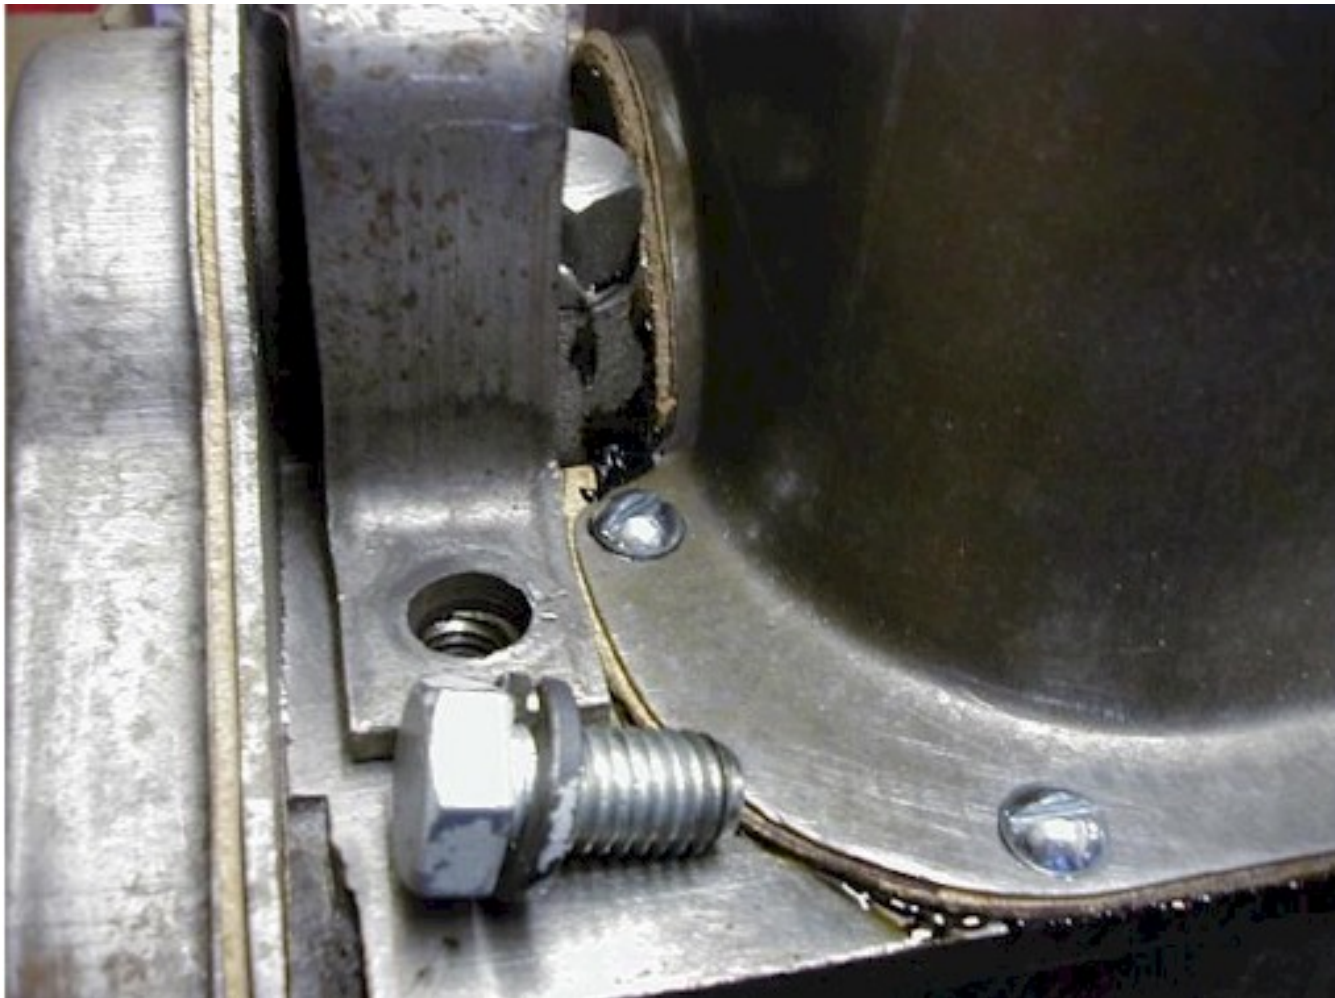
This is the front of the engine and is the motor mount. You can also see the area where the pan connects across the main bearing cap and at the junction you can observe just a small "dollop" of the black RTV. On the opposite side is a through bolt with a lock washer and nut. This side has a through bolt that goes into the front timing gear cavity.

100% credit for that answer Bob. That bolt does in fact penetrate into the cavity that contains the cam and crank gear. If we did not seal the threads on the bolt, oil would eventually escape. This would appear as if the front main were leaking. If this problem exists on your car I suggest you remove the bolt, clean it, and coat liberally with the "yellow snot" and replace.

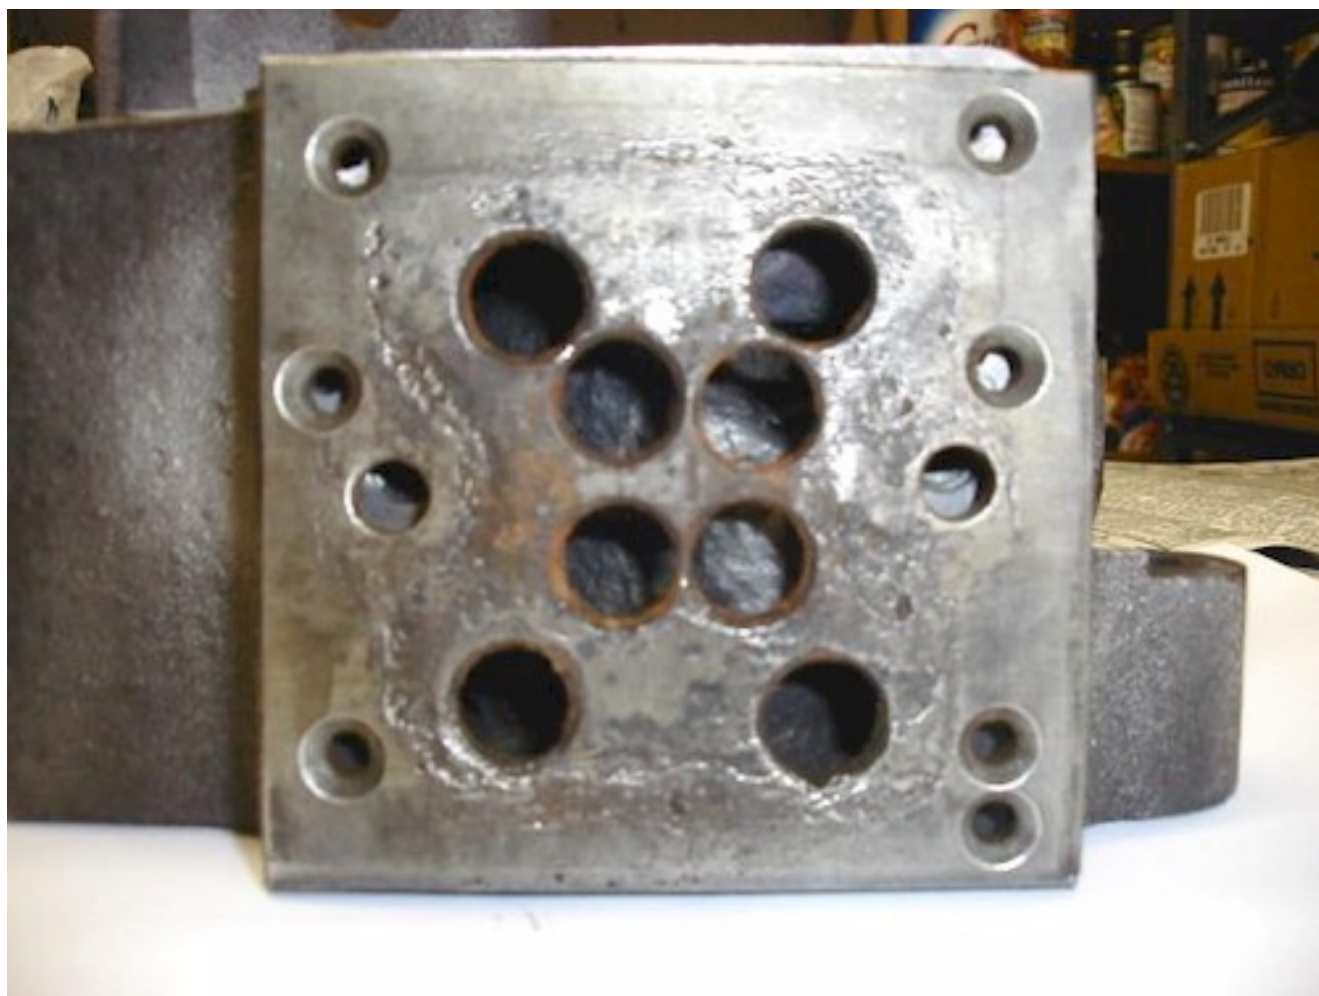
We left unanswered the selected method to attack the broken bosses on the front of the head. Someone was astute enough to observe the 6 small holes drilled in the outer edge of the opening. This was the solution of the prior engine rebuild. These holes were tapped to accept screws to attach a fabricated plate.

This plate was $\frac{1}{4}$ inches thick and was counter sunk at the locations for the 6 mounting screws. Eight large holes were drilled to allow water passage. A gasket was used to mount this plate to the front of the head.

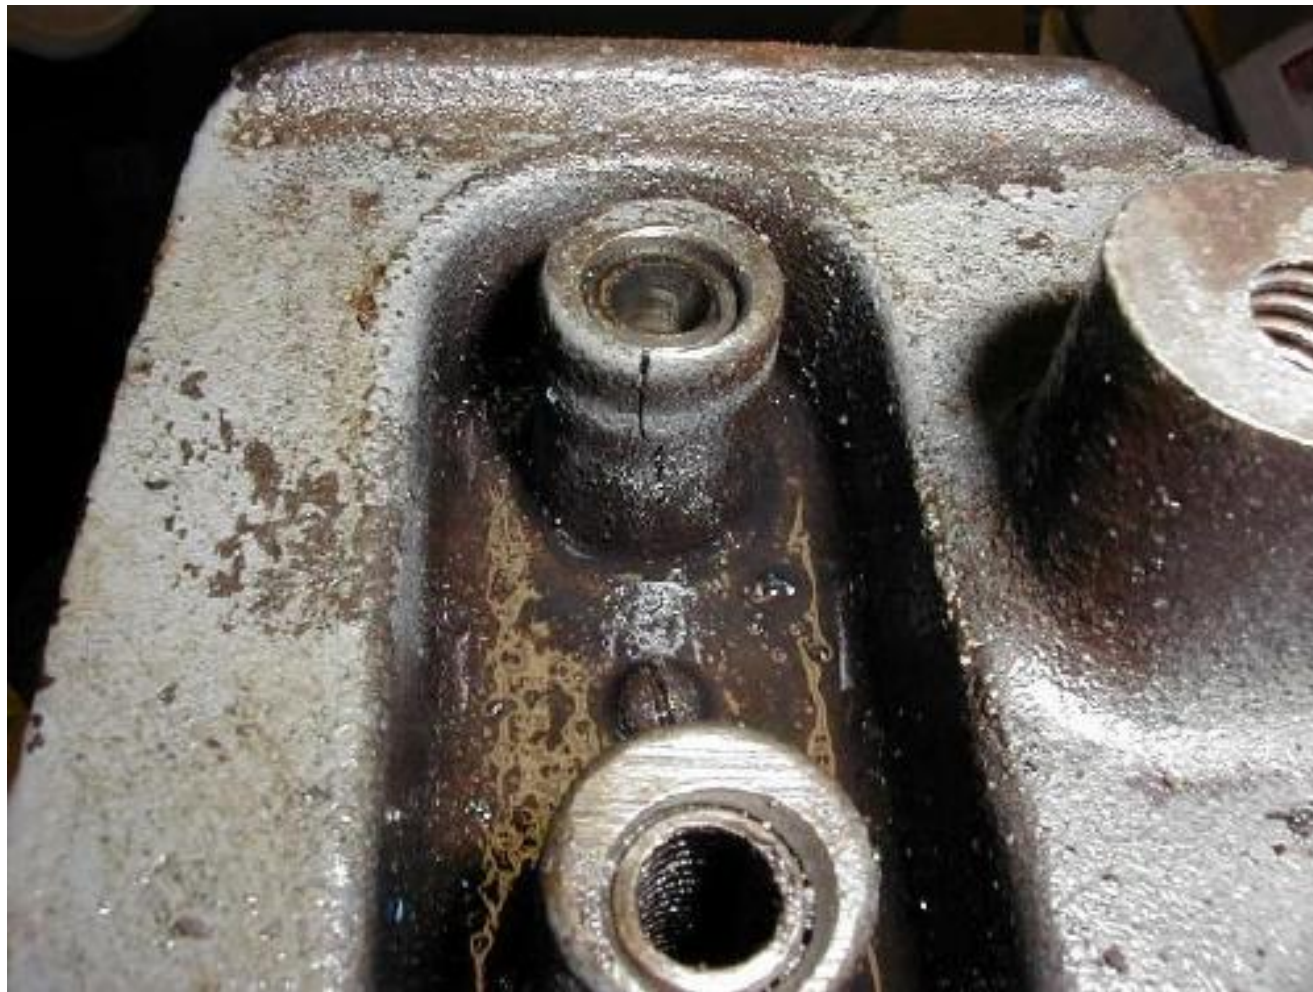
To compensate for worn valve stems and guides, Chevrolet provided valves with oversize stems. The heads did not originally have guides installed. The hole bored through the head was the guide. Years ago when these special valves were available that was an acceptable solution. The accepted solution now is to install valve guides and use standard valves. Guides can be knurled once and if worn out can easily be replaced again. From the picture it is obvious that this head has had guides installed. Notice also that the boss is split on one of these installations. This should not pose a problem and will be used as you see it.

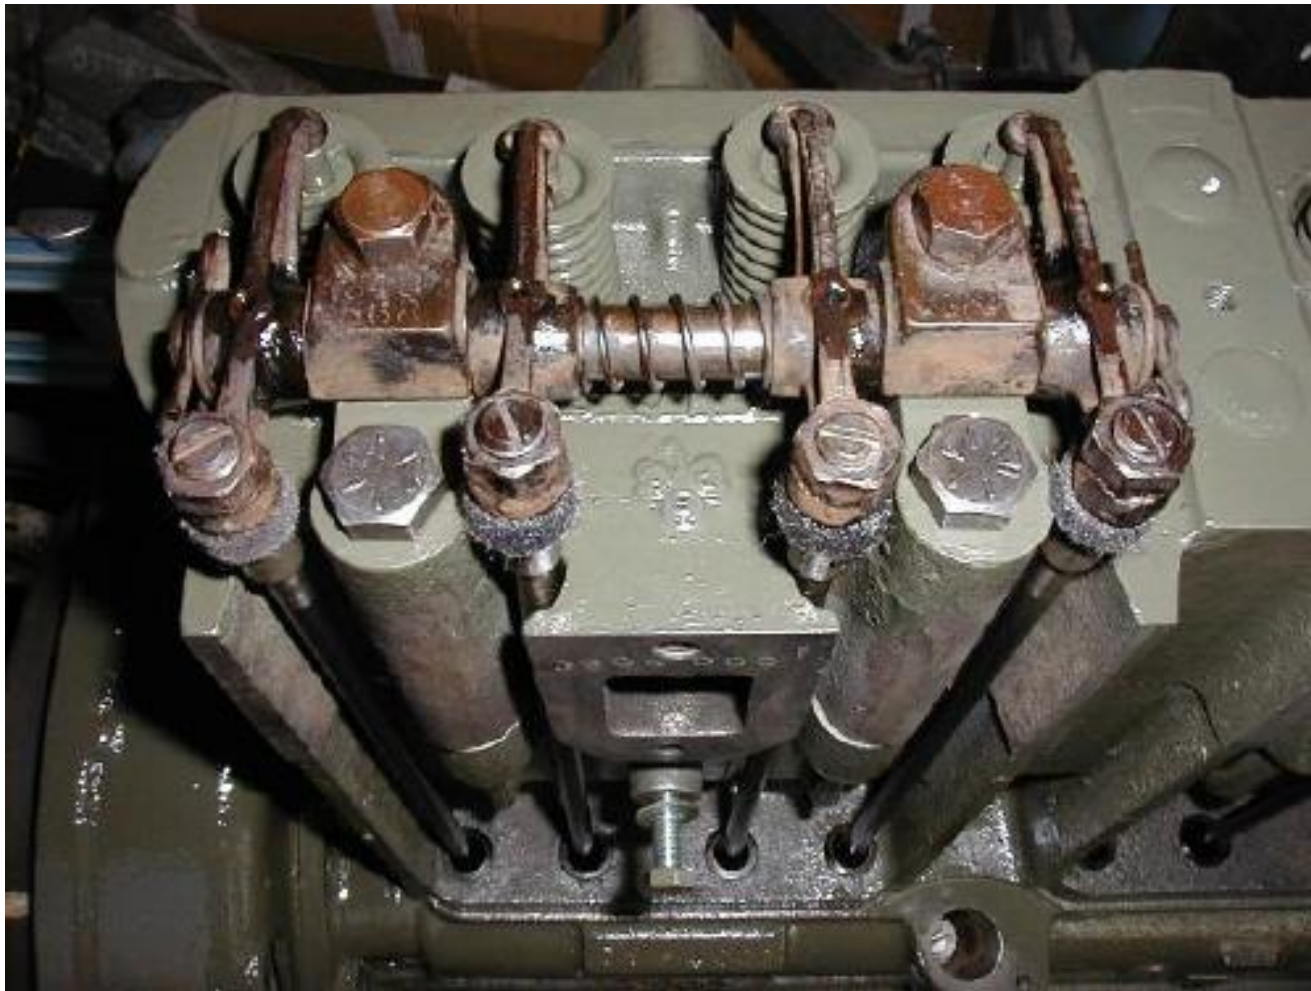
Back to the assembly of the head. In the following picture note the felt rings on the top of the pushrods and under the rocker arms.

If there is a question about these felt rings, rest at ease. They are part number 327647 and are in fact OE. With the valve cover off, each of these rings are oiled with engine oil. Each rocker arm has an oil hole located over the shaft and this position must be oiled also. Before replacing the valve cover a felt pad is saturated in engine oil and placed over the length of the rocker arm shafts. The part number of the pad is 345468. And yes, there are valve cover gaskets, two of them, part number 348561. They are "L" shaped and placed at each end. While on the valve cover, note that it has 4 small holes, two at each end. These holes match up with channels on the underside of the valve cover. The purpose of the holes is to allow oiling of the felt pad without removing the valve cover.

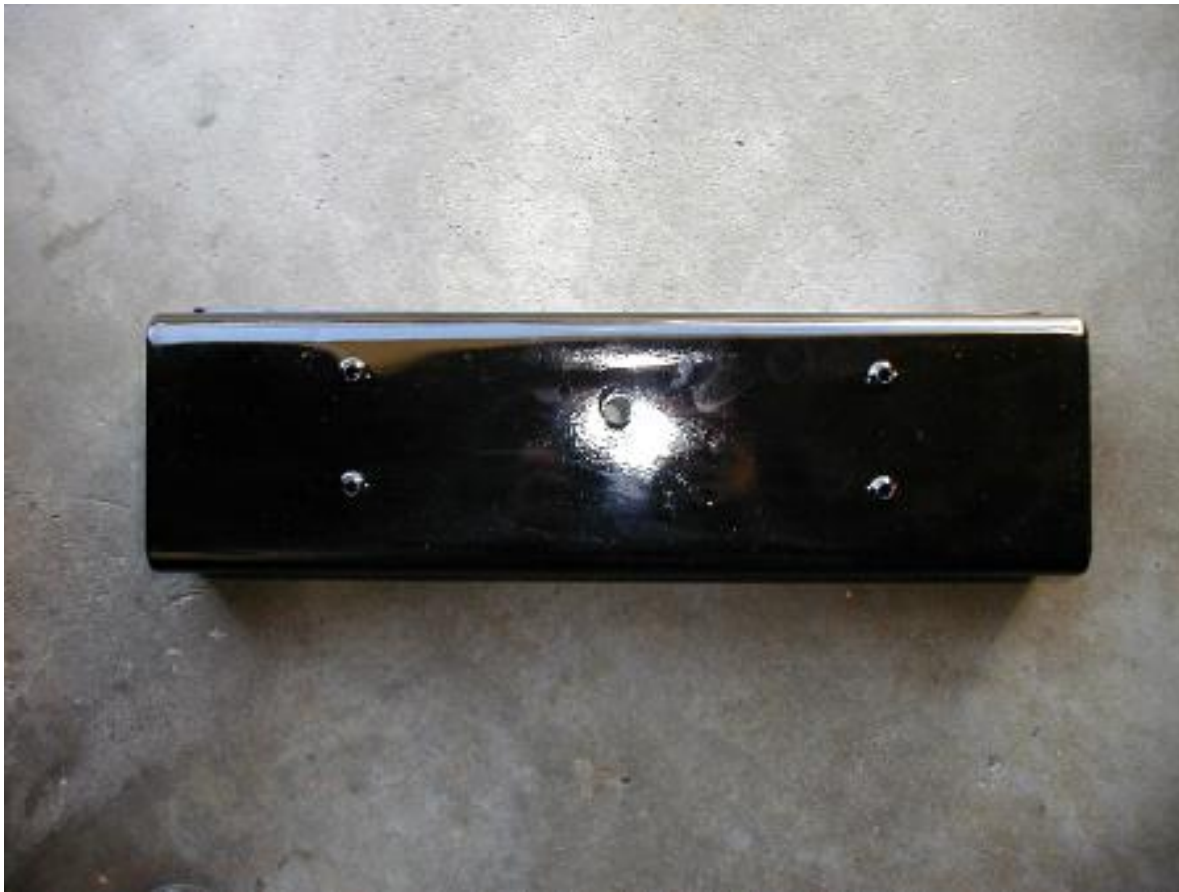
There are a total of 4 holes provided to replenish the oil in the felt pad. Remember, that on assembly, the pad is saturated with engine oil before being placed under the valve cover. The holes are provided so additional oil can be placed on the pad without removing the cover.

If oil is placed in the 4 holes on the top it will be discharged below at each point I have marked with the chalk arrow. This would provide very good coverage of the felt pad.

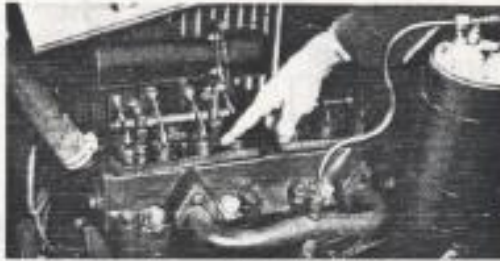
Cars are now shipped without oil in valve pockets. This was discontinued to avoid oil dripping in double decked cars during shipment.

Refer to Figure 6 and see that these pockets are filled on every new car before delivery. If neglected, valve squawks are very liable to develop.

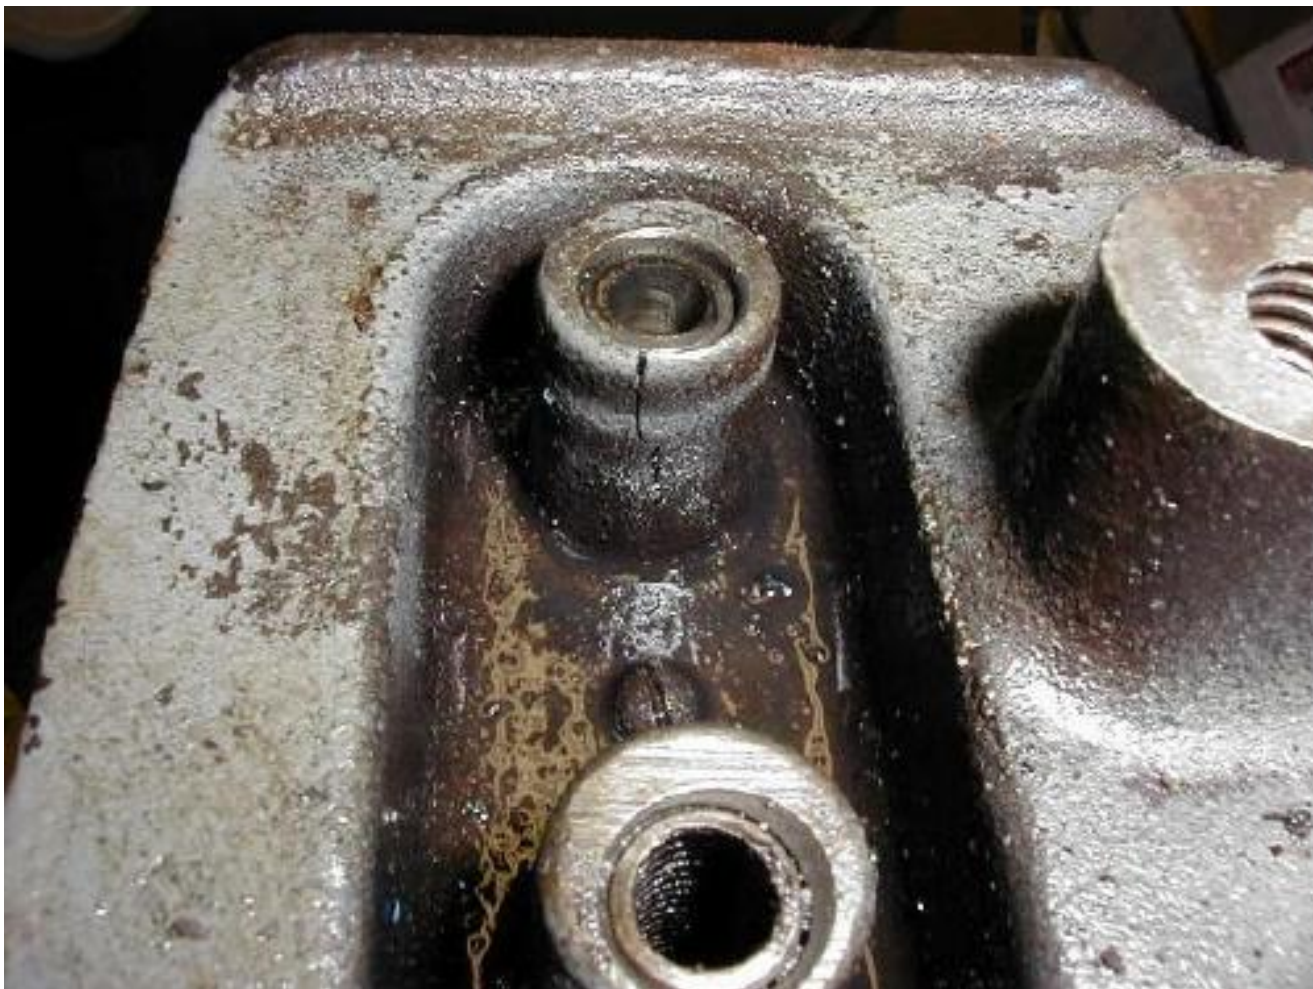
The bosses that the valves operate in are equal to if not higher than the surrounding area.

For any oil to get to the valve stems it would have to be splashed(?) by the valve springs. I would think that if the valves were squeaking a shot from the on board oil can would be sufficient.

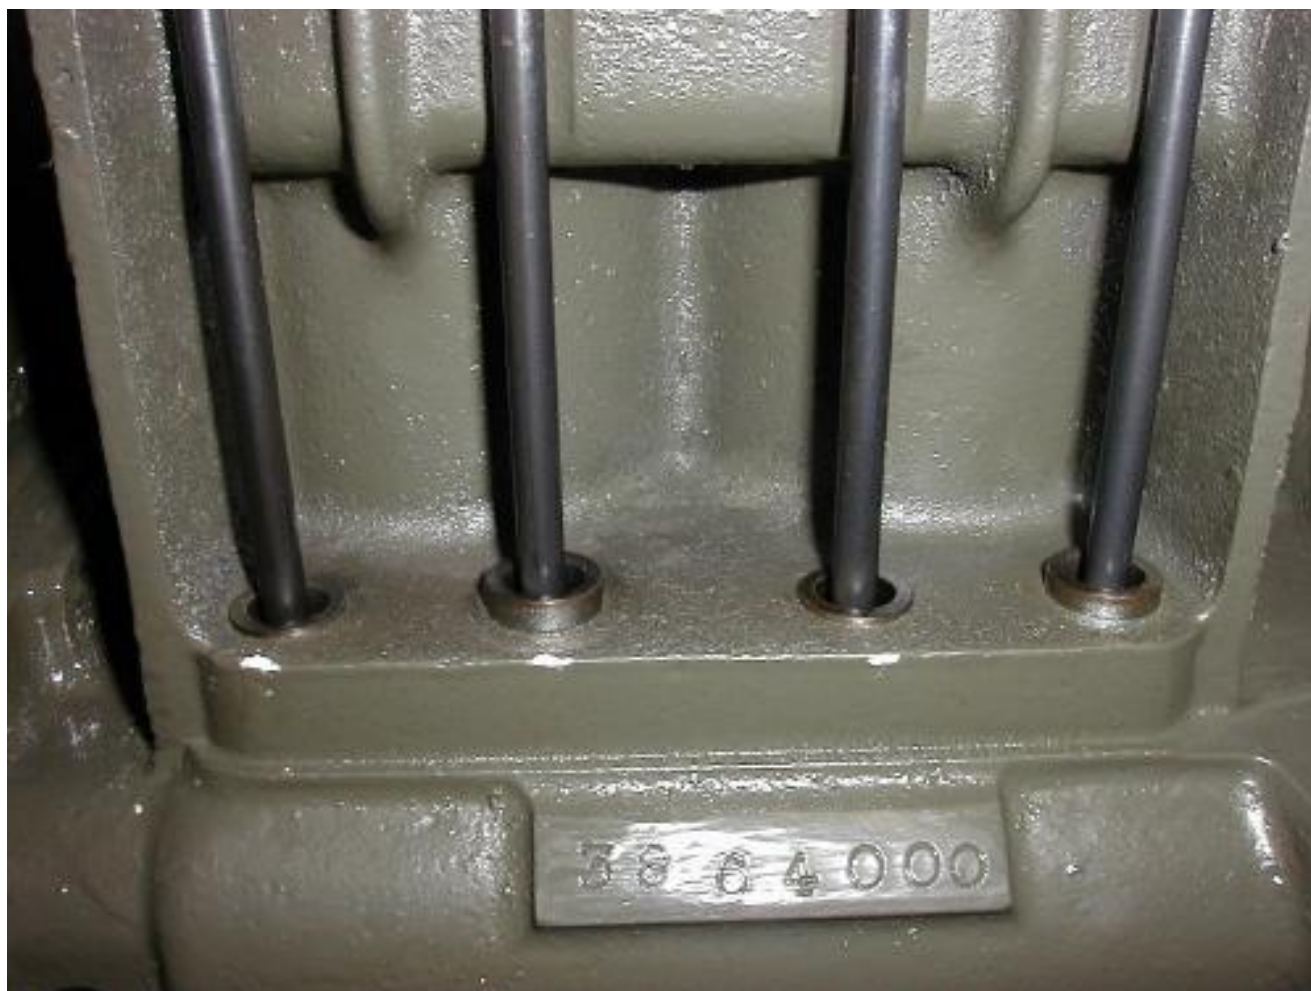
With the side cover still off we have a good look at the lifters and their guides. It is easy to determine which lifter is on a portion of the lobe on the camshaft and which lifter is at the bottom of it's travel. The lifter lowest in it's hole is at the bottom of it's travel and the one to be adjusted. With your multiple feeler gage assortment select the .007 gage. Why the .007, because all we wish to accomplish in this adjustment procedure is to insure the engine will operate. FINAL VALVE ADJUSTMENT CAN ONLY BE ACCOMPLISHED WHEN THE MOTOR HAS BEEN RUN AND HAS ACHIEVED OPERATING TEMPERATURE. The other reason for selecting the .007 gage is that it is easy to find, is in better shape, because it is between the .006 and .008 on your gage assortment which are gnarled and beat up.

The procedure now is to slowly rotate the flywheel and identify the valves which are at the extreme bottom of their travel, and adjust the ***** to the .007 setting. Tighten the lock nut on the adjusting ***** . To make things simple use a piece of chalk or other marking device and mark the valve you just adjusted. Continue to rotate the flywheel until you have identified all 8 valves and adjusted them to .007. After the last one you should turn the flywheel through two complete turns and make sure each rocker arm is loose at some point in the two revolutions.

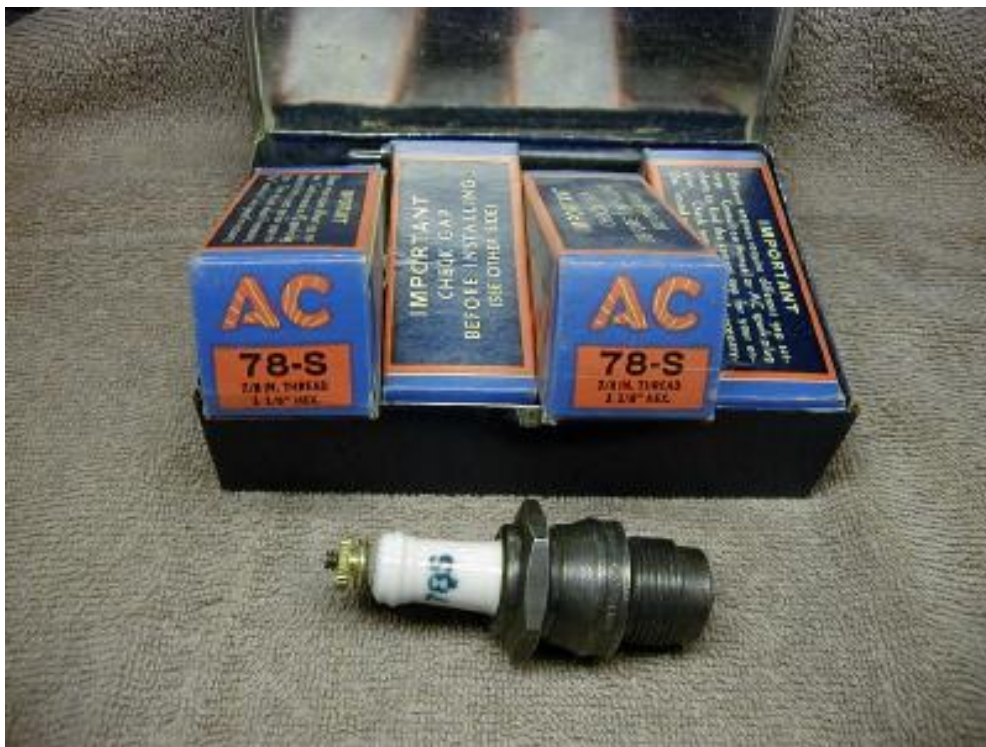
This is a box of NOS AC 78S plugs for the 1928 Chevrolet. The 78 S plug is still manufactured, however it is not the same as the original 78 S in that the projection is only $\frac{1}{2}$ inch.

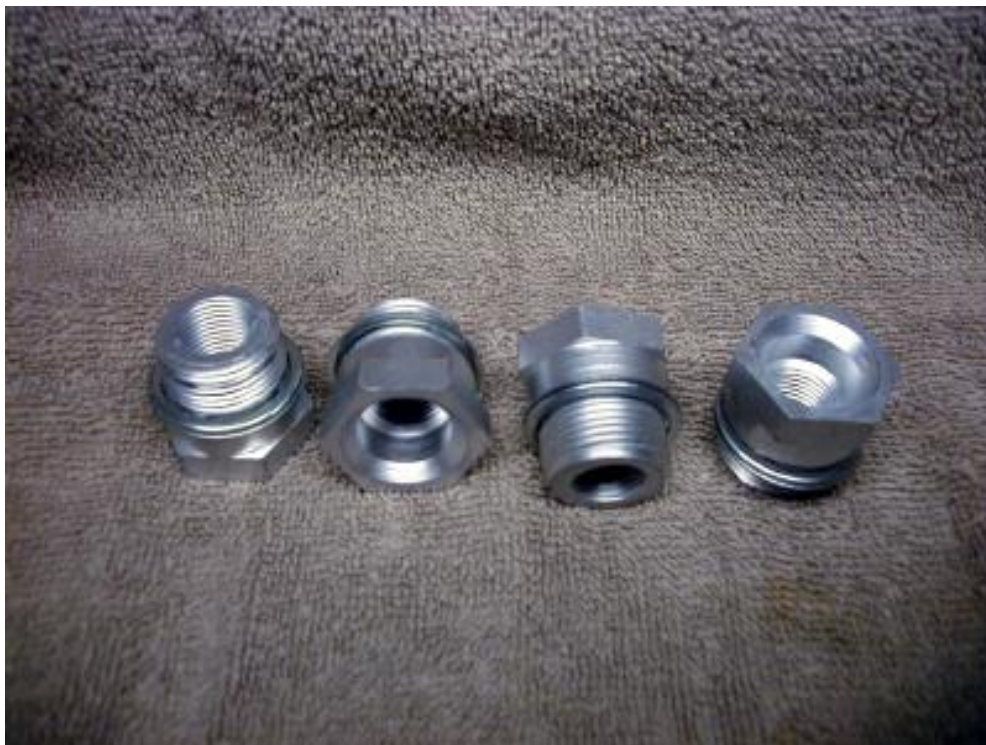
This adaptor allows the use of a modern spark plug in the 4-cylinder engine. The major disadvantage of this arrangement is that no non-resistor plugs are available with a $\frac{3}{4}$ reach. This means that a resistor plug must be used, however if the ignition system is in a good state of

repair the results are completely satisfactory. I recommend that the AC R44LTSM6 plug be used in this adaptor. R=Resistor, 4=14MM thread size, 4=heat range, L=long reach, TS=Tapered seat with extended tip, M=special design electrode, and 6=point gap. When the plug is installed the plug gap is set to .025. Using the codes as listed you can select the makeup of the plug of your choice.

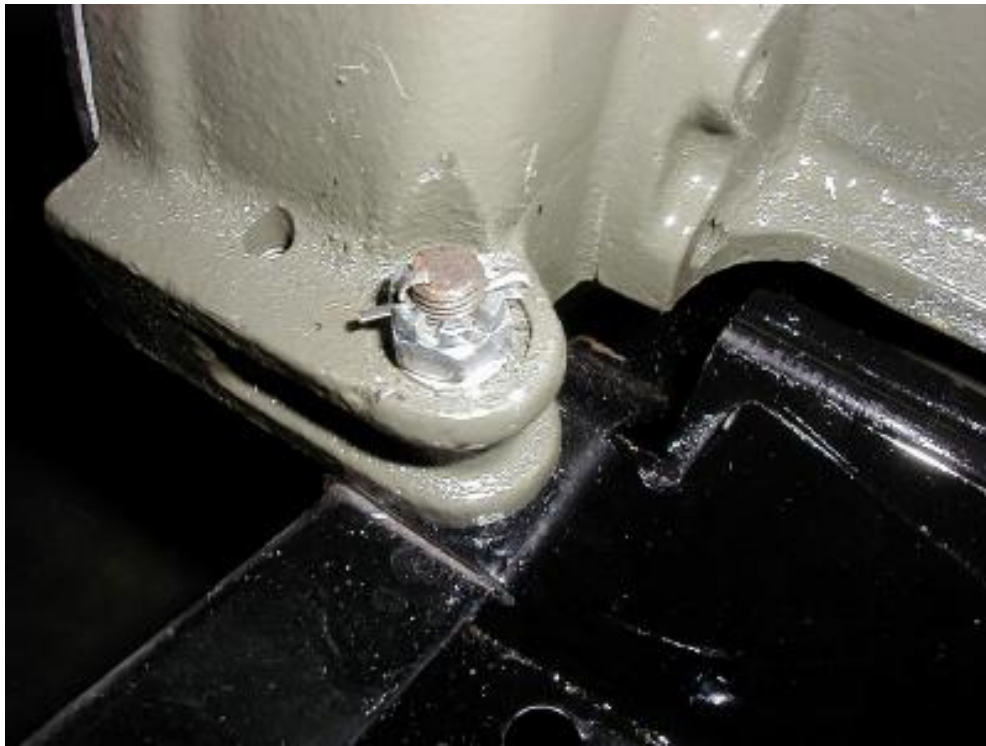
The rear sits on the second cross member and is secured on each side by a through bolt.

It is important to note that the two bolts are inserted through the bottom with the threads at the top. The second thing to observe is that all three items, the stud and two bolts, use a castle nut and cotter key. This is extremely important. A loose engine can cause serious problems and does major wear to the mounting bosses on the engine and the cross members. The two bolts are installed from the bottom in order to make the nuts visible each time the hood is raised to service the engine.

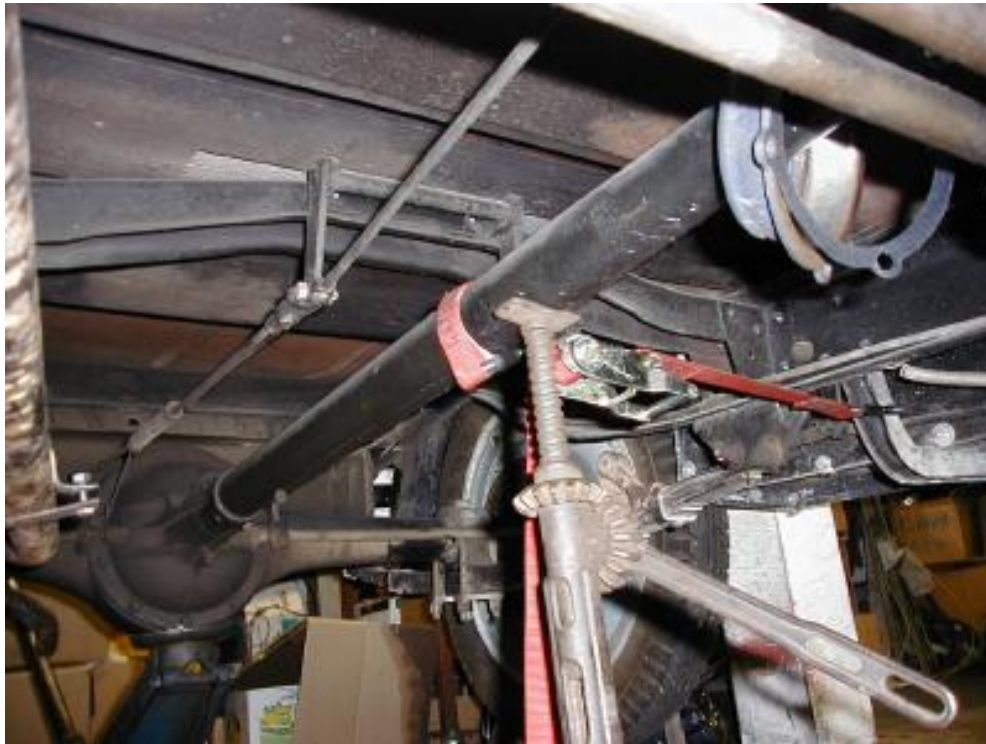
In almost every case the torque tube will not line up perfectly with the rear of the transmission. A jack placed under the tube can assist in the vertical movement. For the lateral movement, a small ratchet strap will handle that chore handily. After the U-joint has been joined and tightened, don't forget to remove the bailing wire.

If the torque tube does not line up close to the transmission when free, the reason should be investigated. This may indicate that some component in the rear drive line is bent or damaged. In any case it is considered good procedure to loosen all the nuts on the U-bolts that attach the springs to the rear axle housing. Make the U-joint connection and then don't forget to return the nuts back to the tight position.

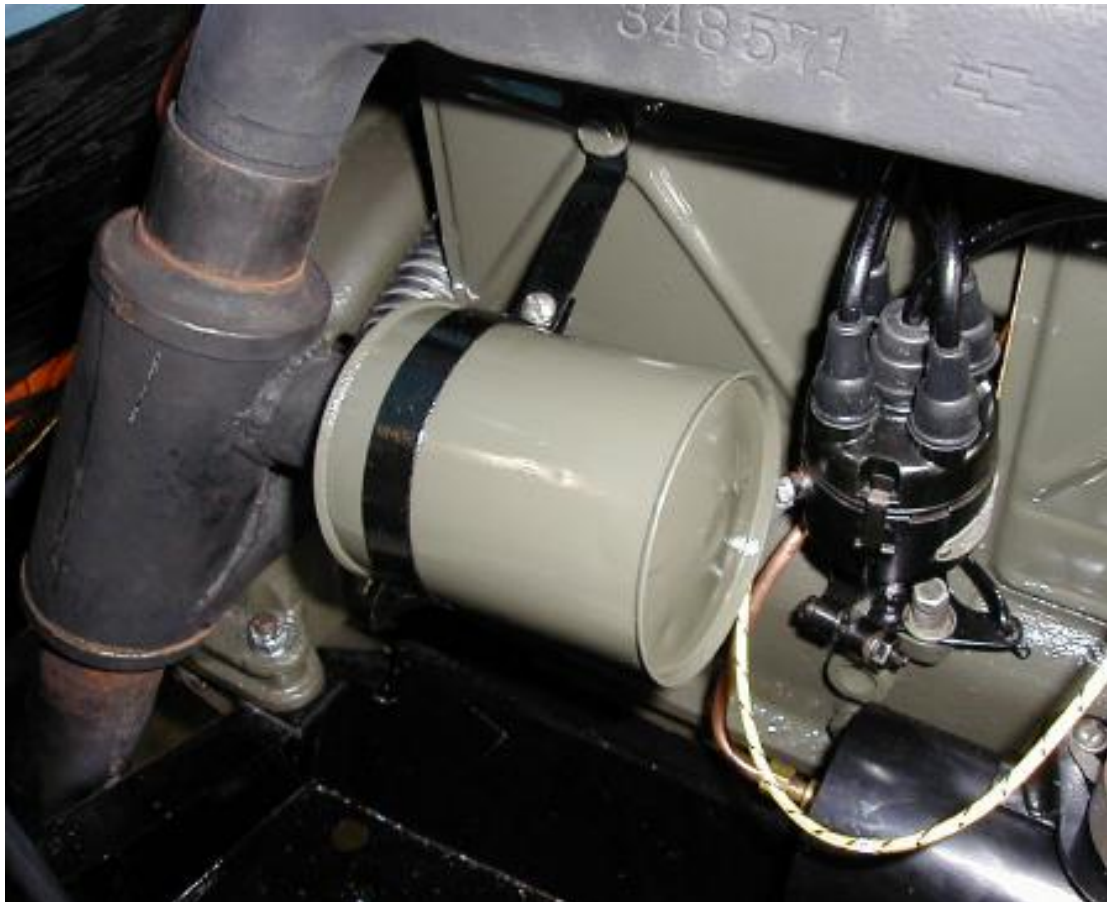
With the air cleaner installed (yes, I know it is missing the decal which will be applied later) it is virtually impossible to see into the hole and view the timing mark.

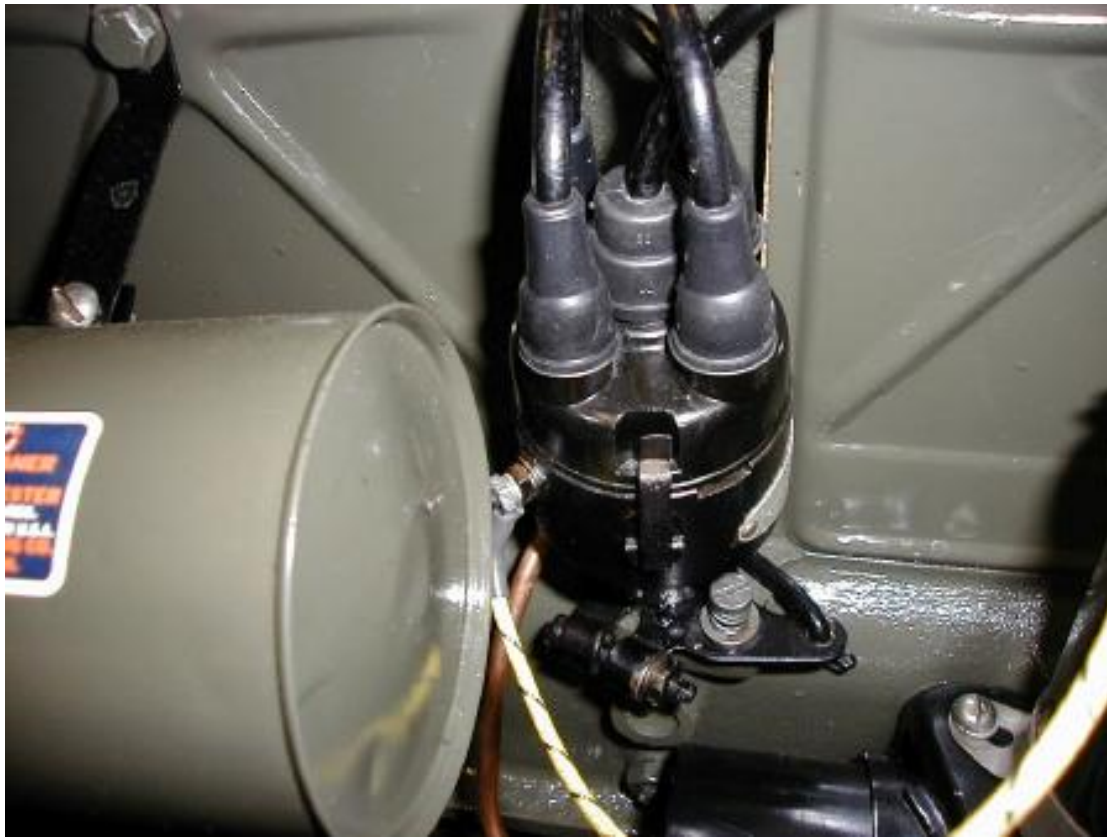
This is a picture as installed. Note that the clips for the distributor cap are 90 degrees from the line of the engine. This puts the back clip between number 2 and 3 cylinder and as a result it is extremely difficult to get to. Obviously this is not the correct way to install the distributor. I decided it would only take a few minutes to correct this error and I could then take my pictures. To make a long story short there was no way I could install the distributor correctly. I checked the model number 635B and that is correct. I dug out some more distributors and found another identical, however another one was completely different, and all had the same model number 635B.

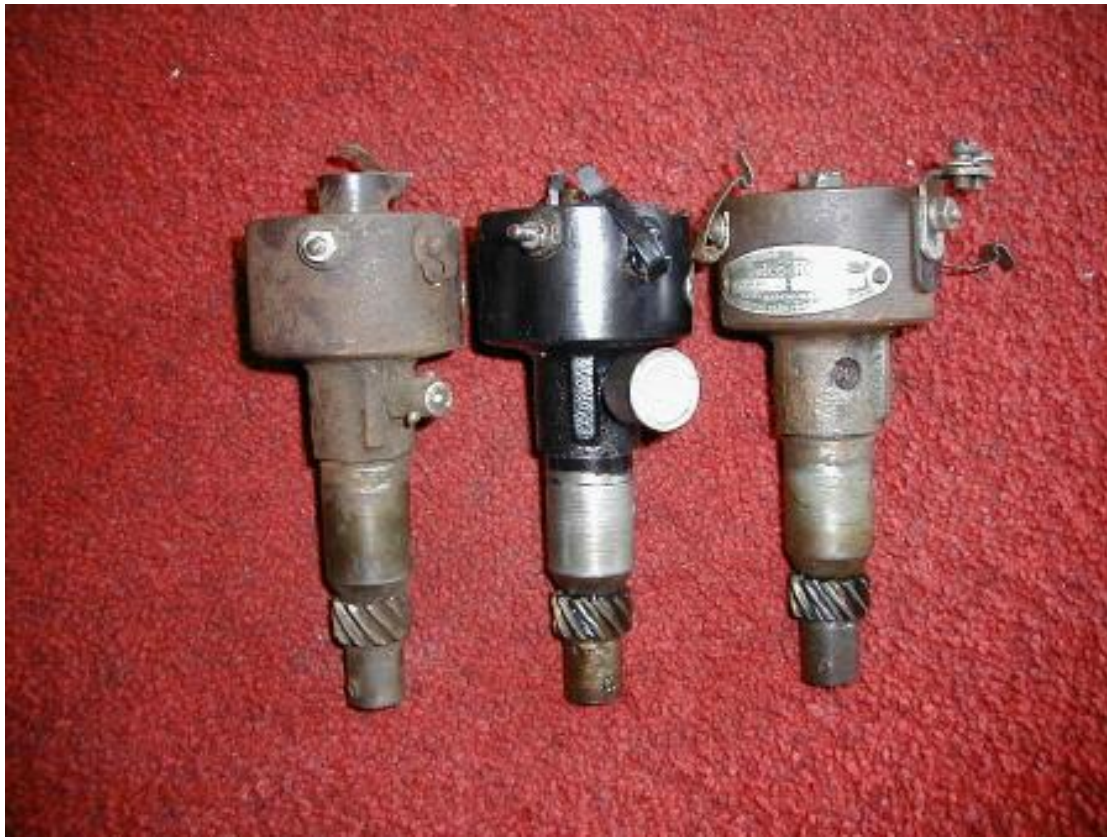
Observe these three distributors closely. Look where the data plate is located, check the grease fitting versus the ridge on the base, and check the location of the stud where the wire from the coil attaches. The two on the left are the same, however the one on the right is different. After much research it was discovered the one on the right is the only distributor that could be mounted as required. So, stop everything and let's rebuild a correct distributor.
