**Chevrolet Four Cylinder
Engine Rebuild Discussion**

From the chat site of:
The Vintage Chevrolet Club
Of America

Teacher: Raymond Holland

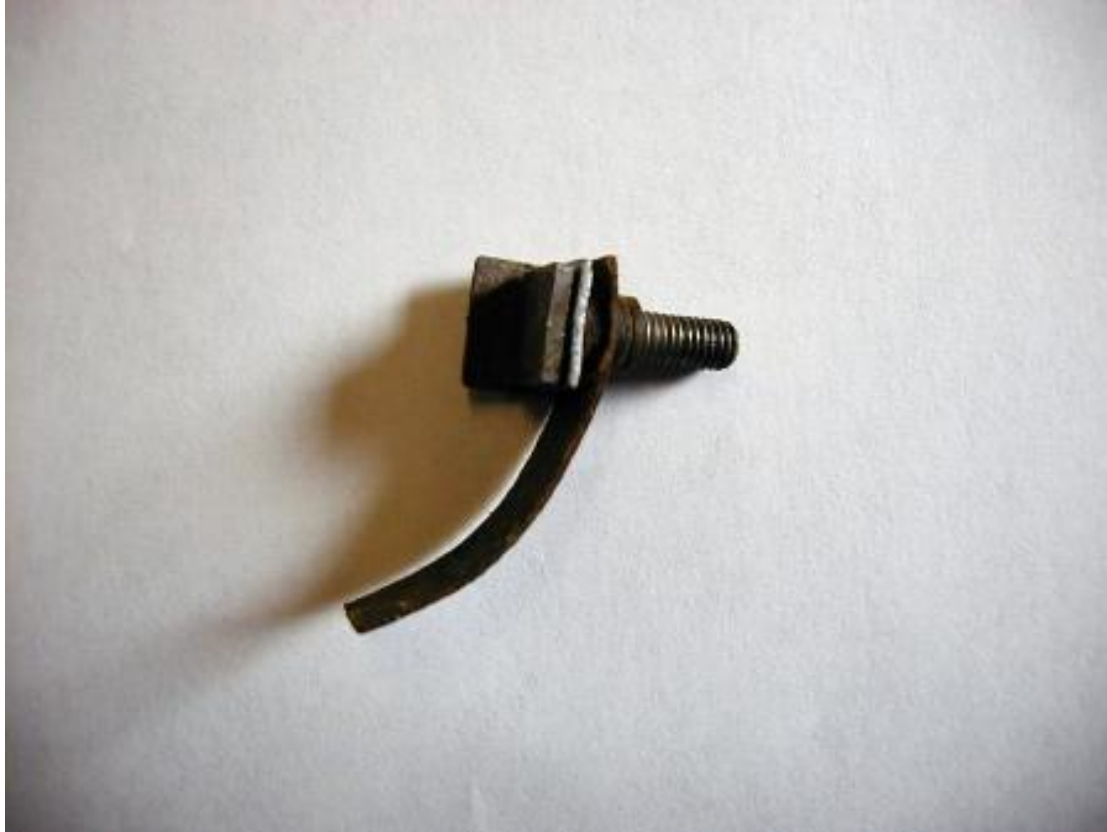
When working on a distributor, or changing the points, inspect this special piece of insulation that is located on the contact post. It is a critical part of the operation of the distributor.

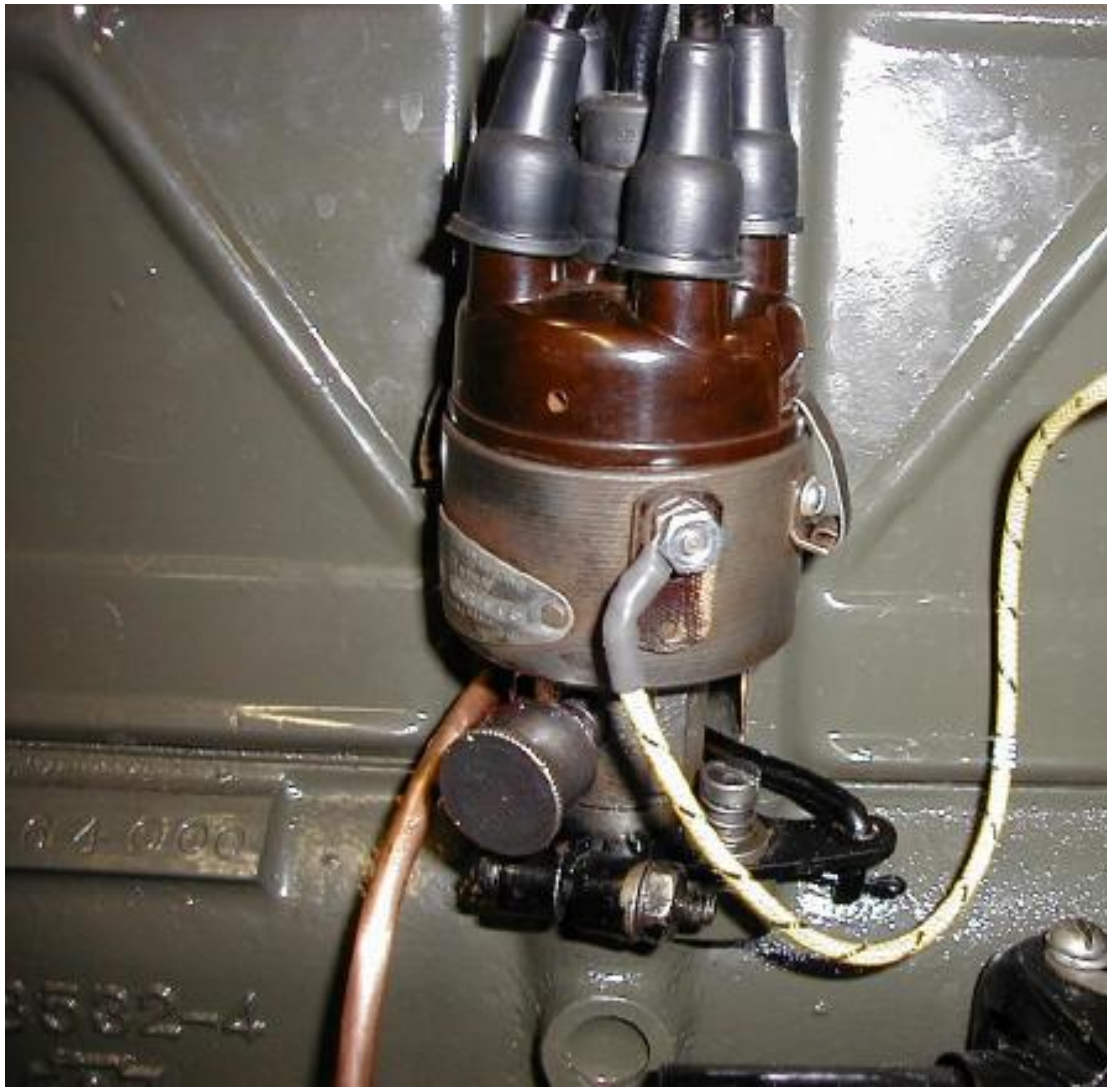
Distributor installed and timed. Now the clips for the cap are parallel to the engine and can easily be accessed for checking the points or making adjustments.

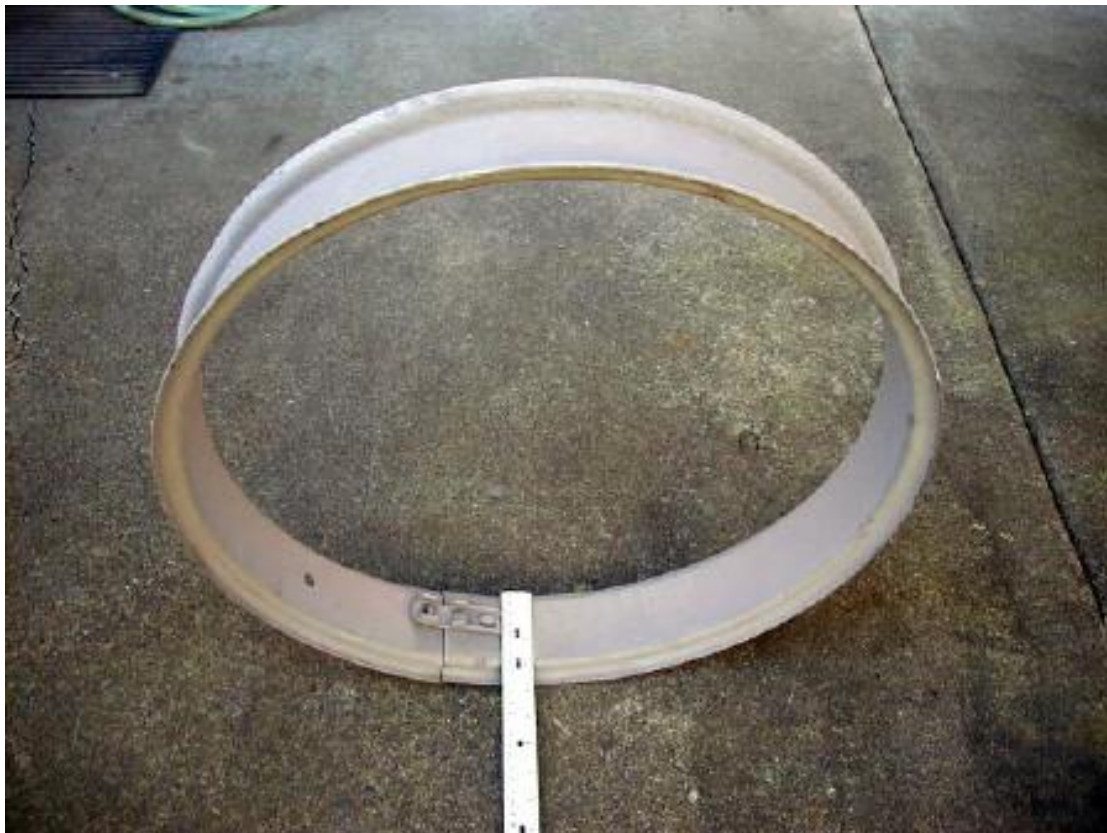
While the engine work has been progressing, other adventures are also taking place. All 5 rims on the car were the wrong size. (They were 2 ½ inches as measured across the inside of the rim. This made them Capital AA 1927 rims). A set of 5 correct rims of the proper size has been obtained, sand blasted and just returned from the cadmium plating shop.

This measurement is to be 3 inches for the 1928. The diameter is 22 ¼ from the extreme outer edges. The tire size is 30 X 4.50 straight side balloon. Modern size for the 1928 is 4.40/4.50X21.

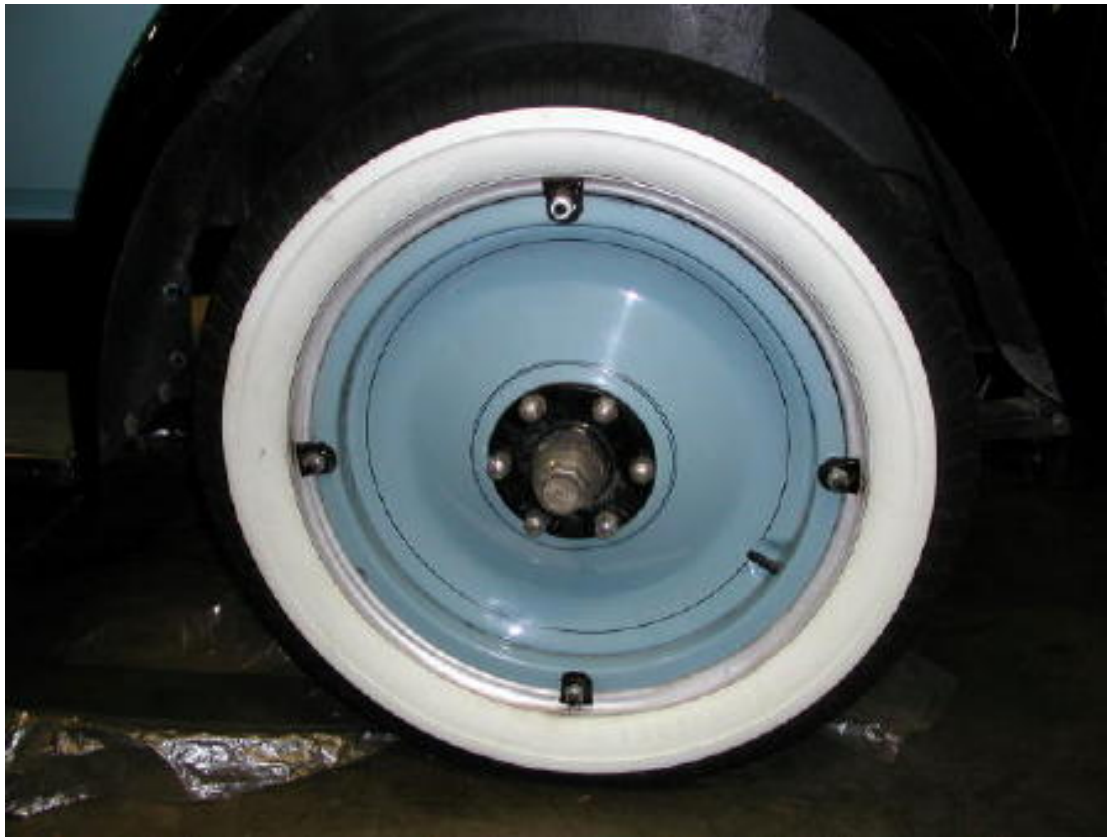
The rim can be mounted in one position only.

The split in the rim is at 3:00 o'clock and must be located at a rim bolt. With the tube stem through the hole there is no other way.

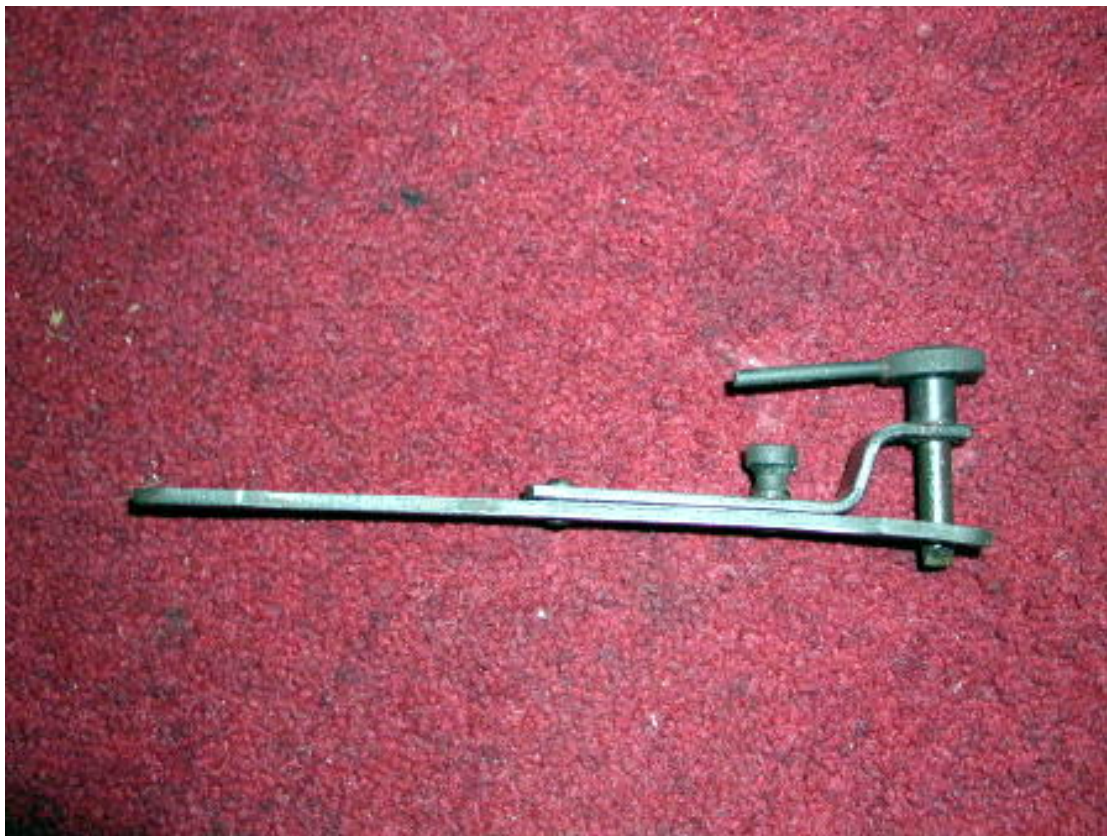
This is a very valuable tool to use when adjusting valves. The wrench part is placed over the stop nut on the rocker arm, loosen the lock nut and then use the built-in screwdriver to make the adjustment. Check progress with a feeler gage. If you make a mistake it should be in the excess. That is, make the adjustment too loose rather than too tight. If the valves are adjusted too tight there is the possibility of burned valves.

minutes in order to bring it up to operating temperature. If you remember on the initial assembly the valves were all set at .007. Now we must set them to the proper specifications, which is: Intake .006 and Exhaust .008. I recommend that a vacuum gage be attached to the engine as a visual reference when setting the valve clearance.

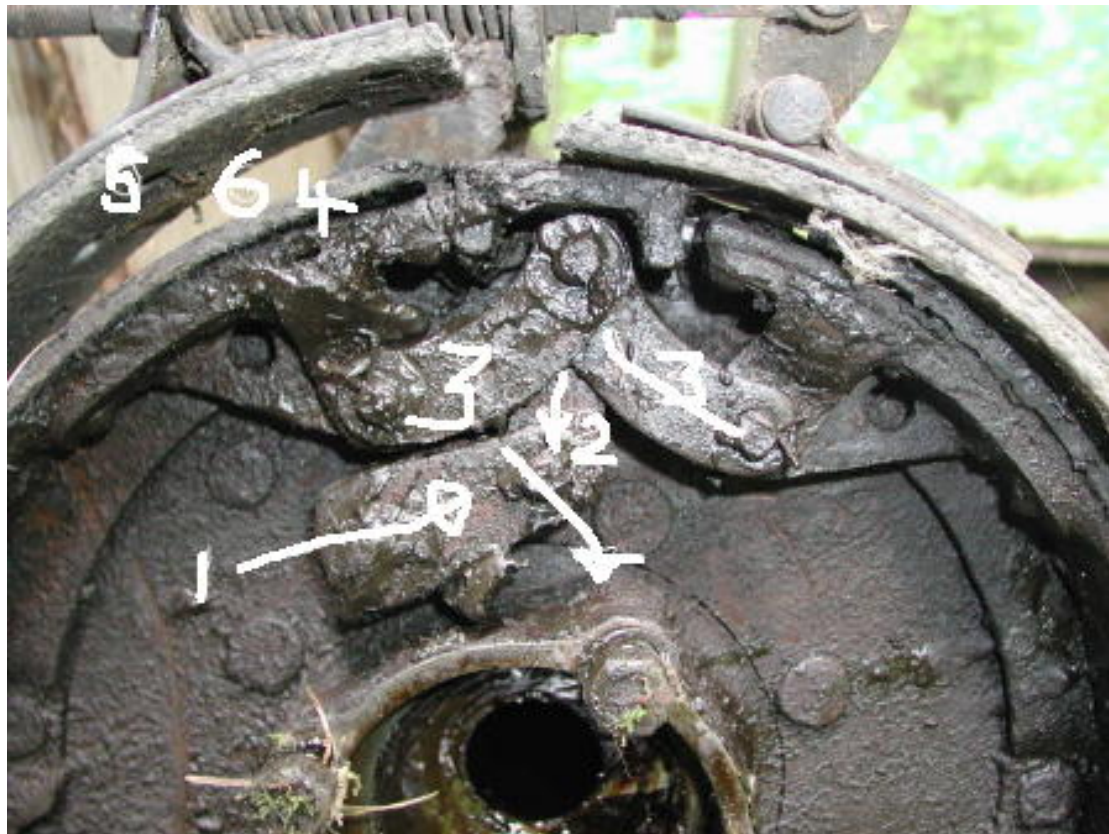
This is the brake housing with the axle and brake-drum removed. Identification of the parts:

6. This is the area where the brake drum would be if installed.
5. This is the service brake band and is completely independent of the parking brake system.
4. This is the parking brake band. Where the service brake would be engaged by compression of the band, the parking brake is engaged by expansion.
3. These are the links from the parking brake band to a central control link.
2. This link picks up the two links from the parking brake band and connects them to the actuator arm.
1. This is the actuator arm. The arm pivots on the left end where it is attached to a rod that goes

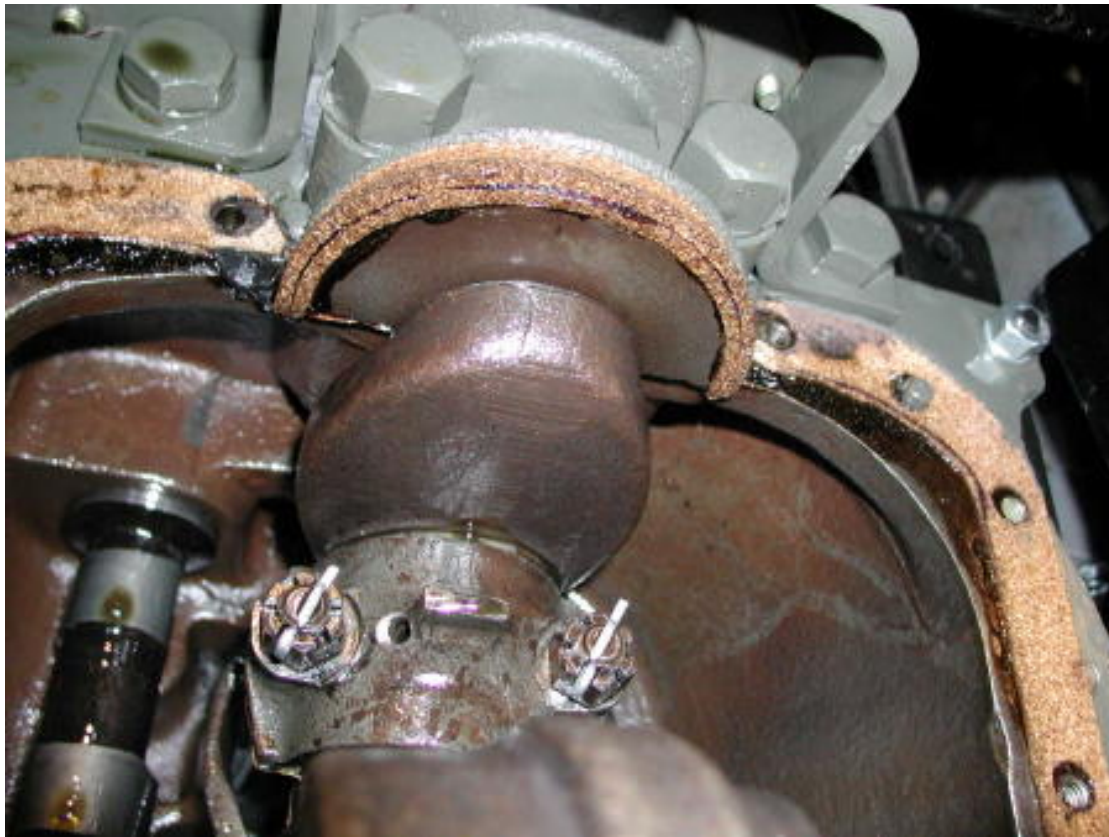
This is the front main bearing cap.

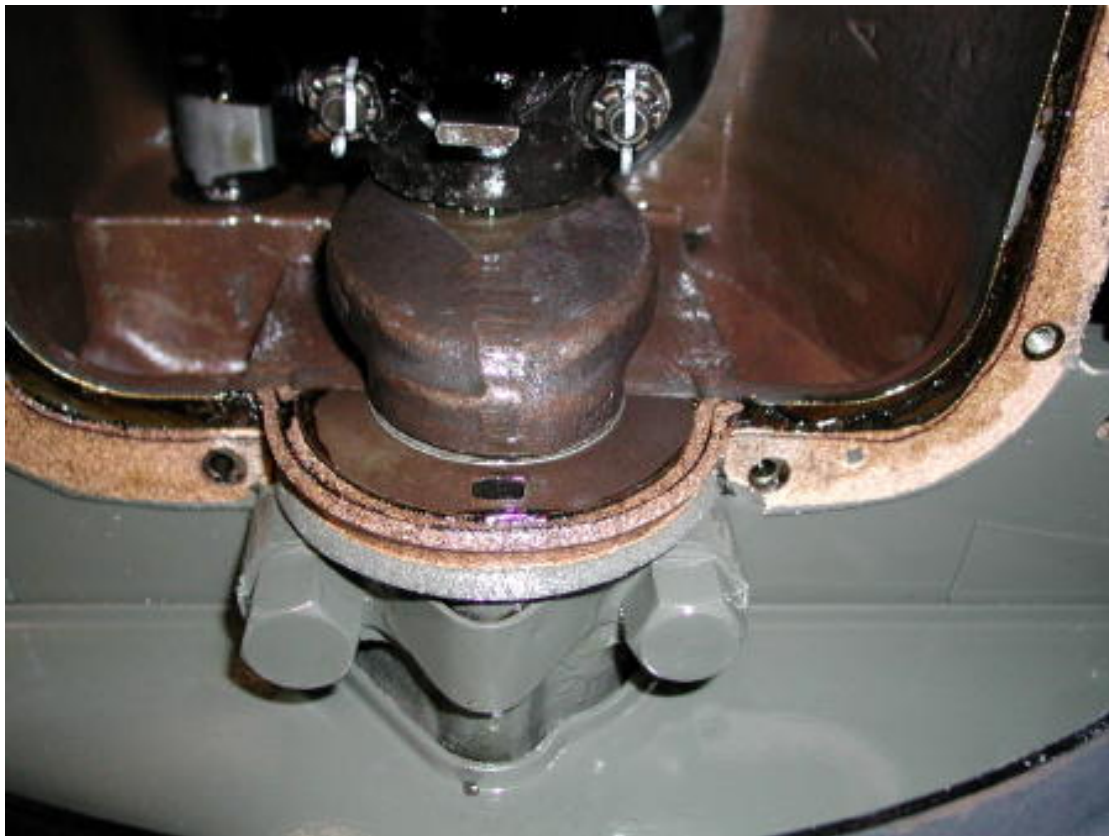
This is the rear main bearing cap. Notice in both cases how the pan gasket is still undisturbed and intact. Close inspection also failed to find any evidence of oil leaks. These results were achieved by gluing only one side of the gasket and by forming special shaped gaskets for each

main bearing cap.
